GOVERNMENT OF JAMMU & KASHMIR

Chief Minister's Monitoring Cell

"Construction of SPS Museum, Srinagar" (Physical Verification Report)

PHYSICAL VERIFICATION REPORT

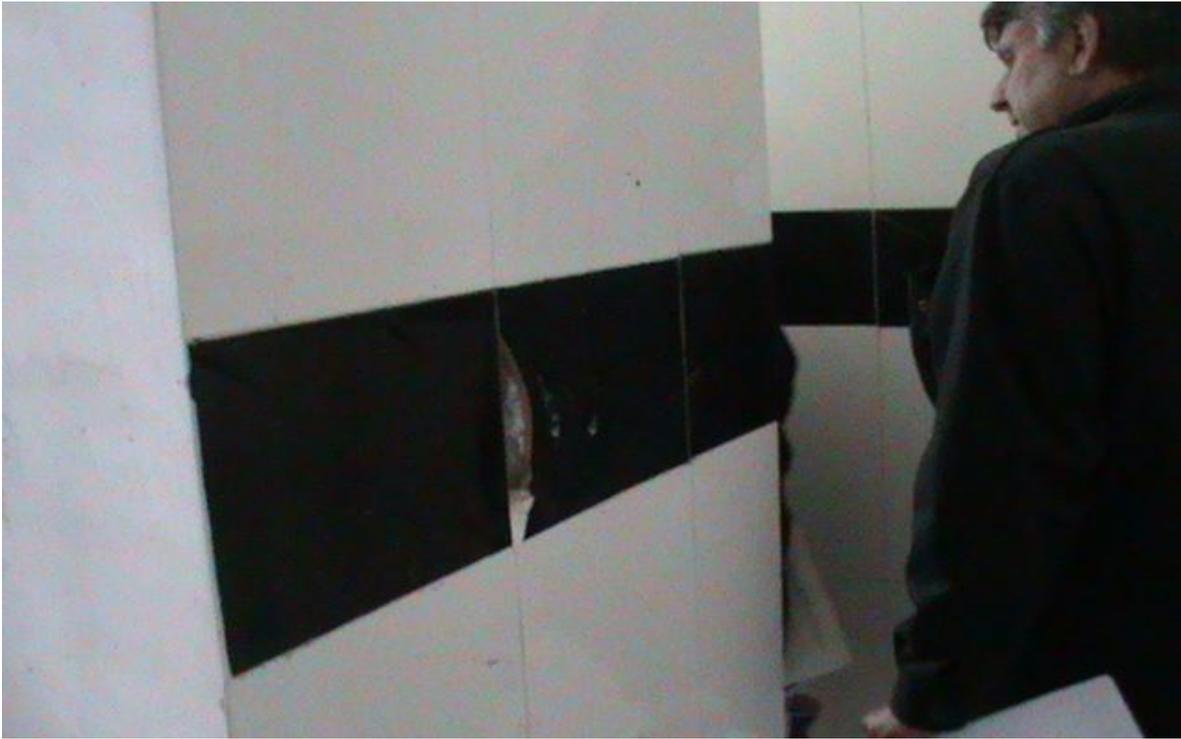
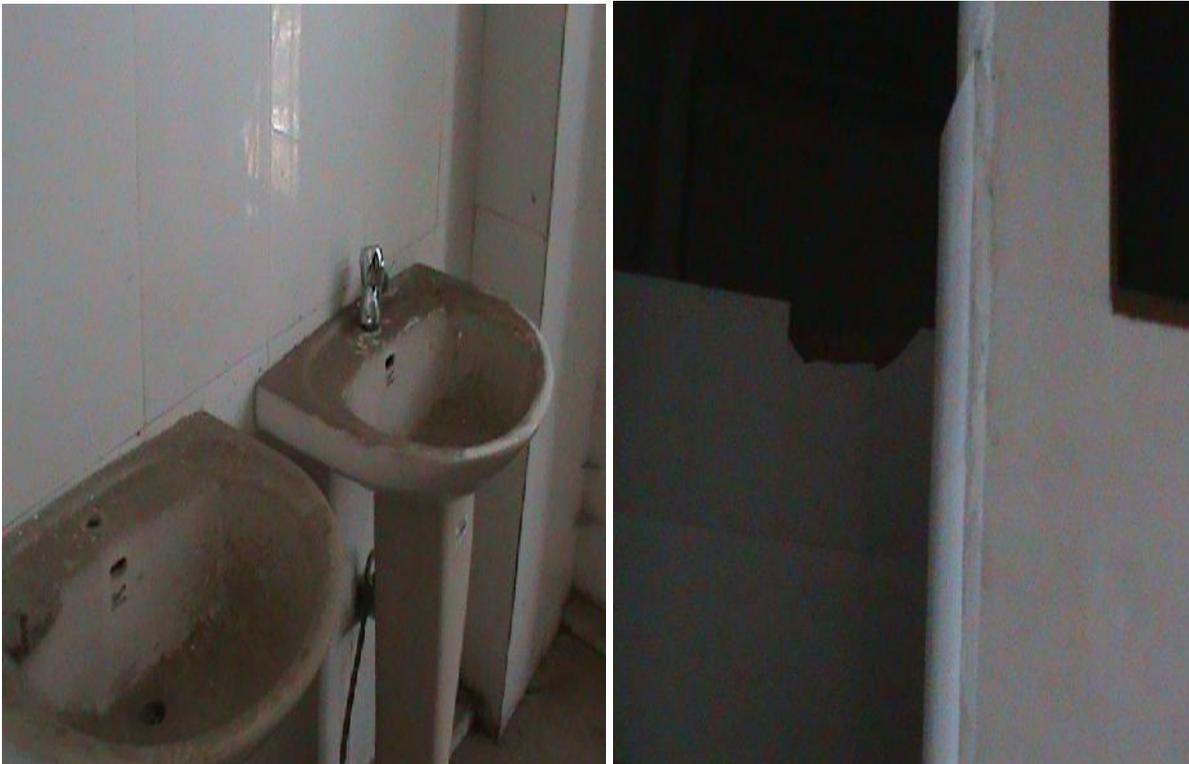
and lavatories. The wooden flooring provided in one of the rooms had swollen in the middle portion besides the workmanship quality in providing wooden skirting in the walls and around circular pillars was noticed poor. Also in two lavatories the broken and cracked tiles at few spots were found fixed. It gives an impression that this part of the work has been executed in a perfunctory manner and the executing agency has not maintained proper supervision during the execution of these finishing works. It further appears that skilled manpower had not been engaged for execution of this kind of technical work. The marble sheets provided in the stairs were also found broken on edges at many places. The executing agency is already on the job for rectification of these errors as was noticed on the day of physical inspection. The improperly laid tiles were being removed and fixed afresh. Further, the material used in the wooden flooring did not appear to be of standard quality but this aspect needs to be verified by a technical person. Even after the completion of most of the finishing works, the building from inside has not been maintained properly as a result of which the doors, floors, lavatories were found replete with inches of dust which makes the building to look very shabby from inside.

Broken / cracked files in common toilets with dusty conditions

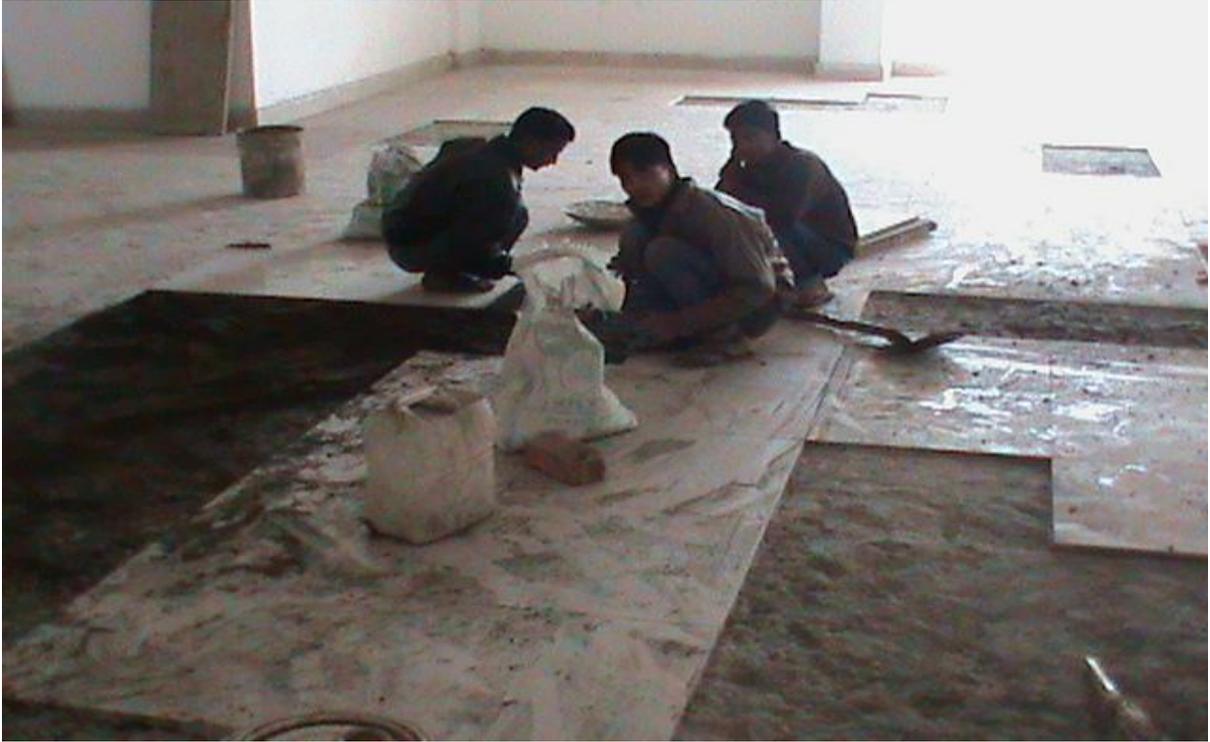
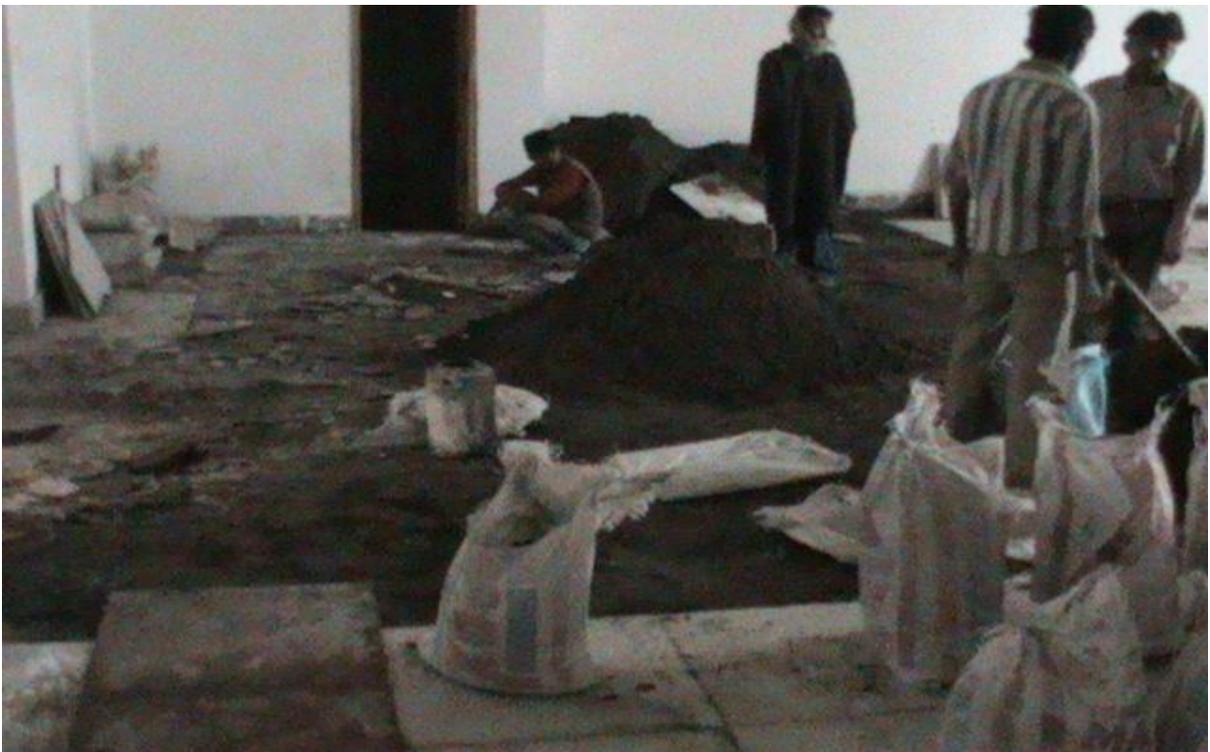
The quality in respect of certain items of finishing works was not found so satisfactory sofar it pertains to the laying and fixing of tiles, marble sheets and wooden flooring at some spots in few rooms, corridors

Improperly laid tiles being removed and fixed afresh

The executing agency should prepare the DPR if not already prepared, which among other things should indicate the detailed cost estimates for each item of work duly back up with the technical vetting from the competent authority and submit it to the concerned quarters for necessary action. It should also maintain always proper supervision during execution of works besides ensuring engagement of skilled workers.

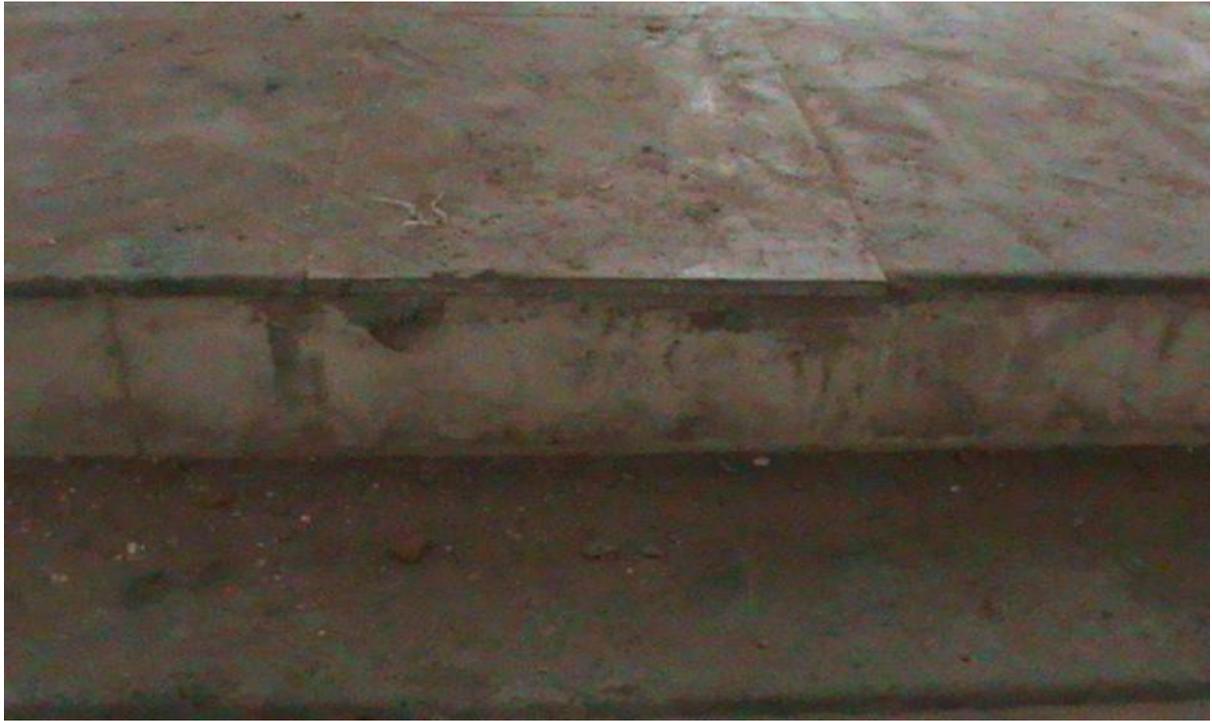
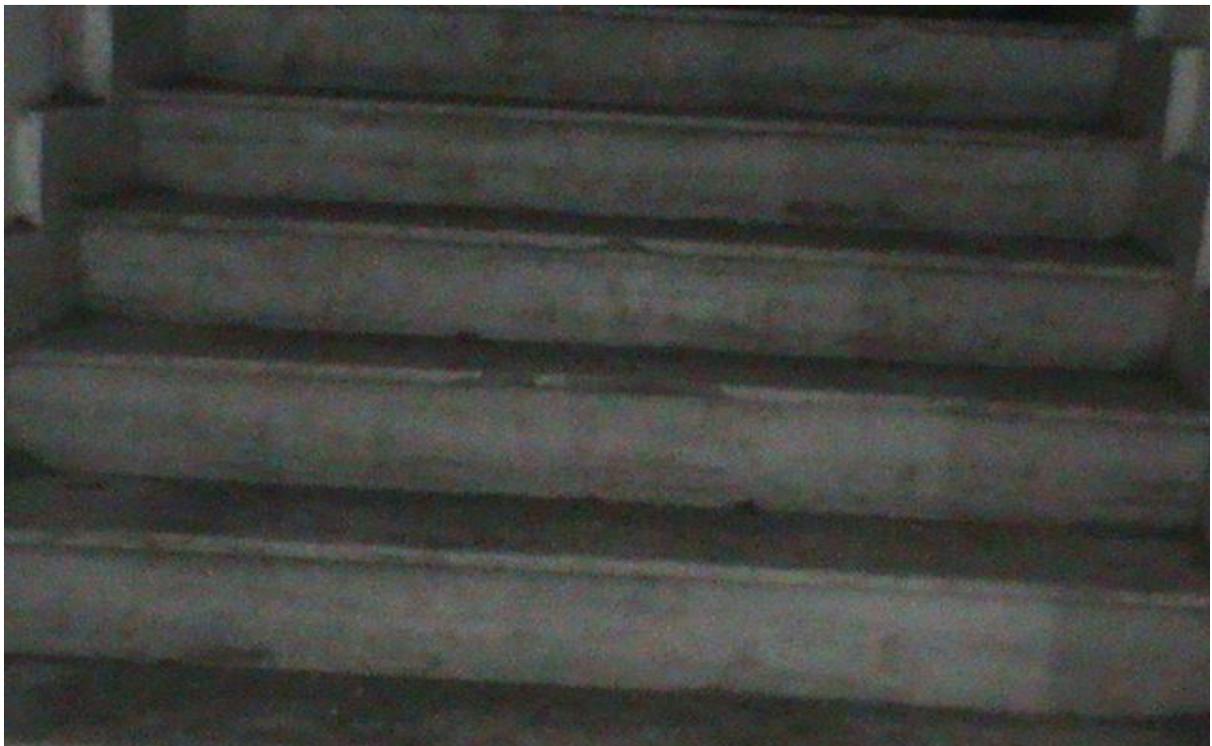
Broken edges of the marble sheets in stairs

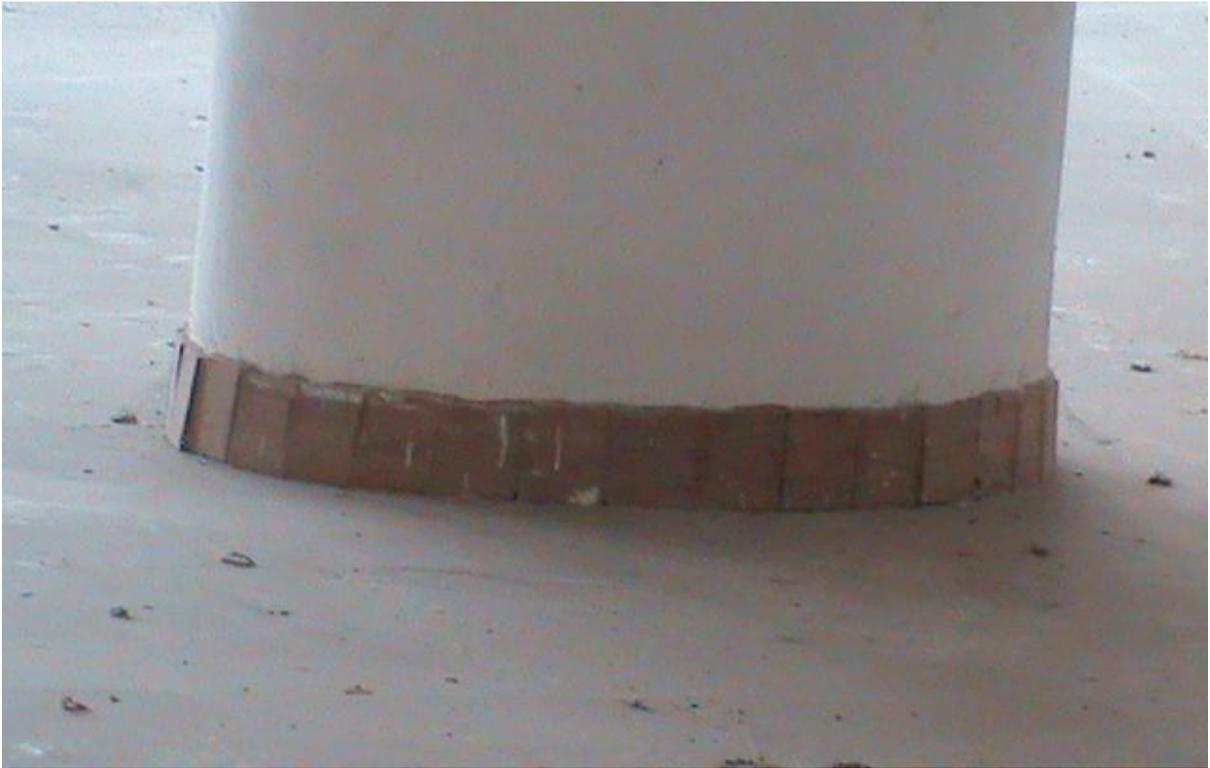
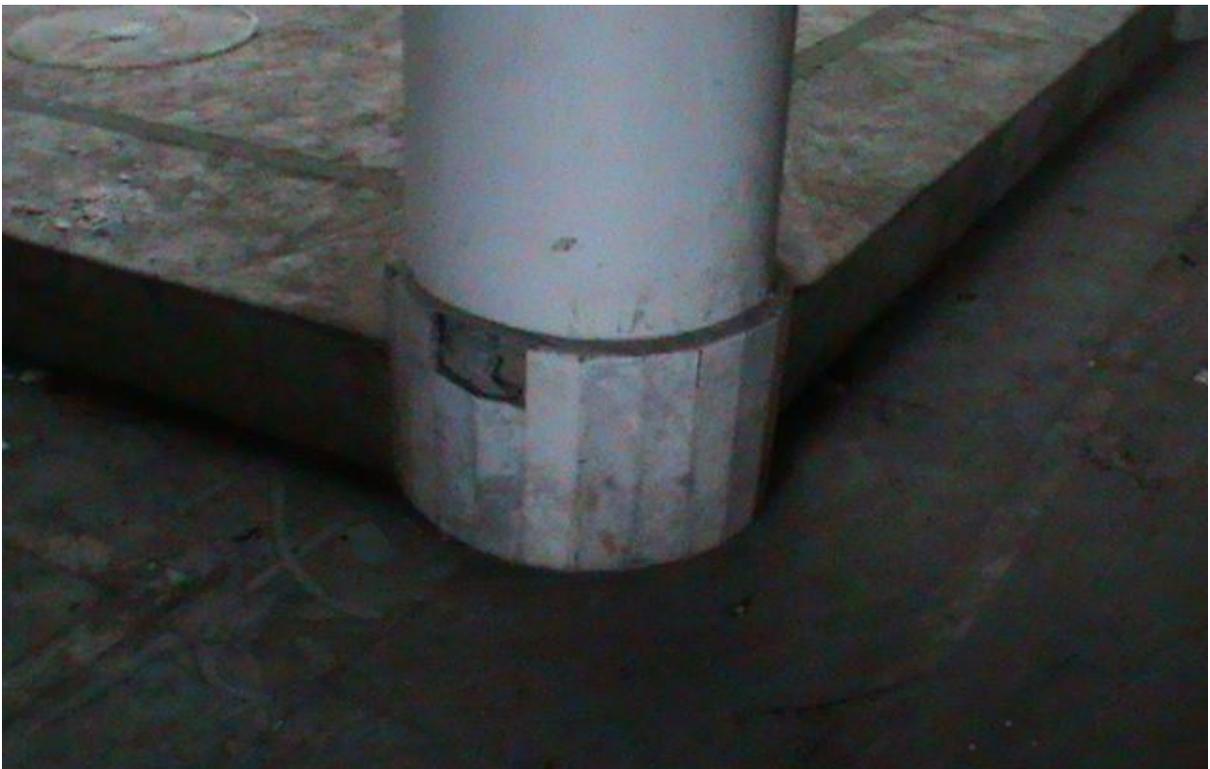
Poor workmanship quality in providing of skirting around the pillars

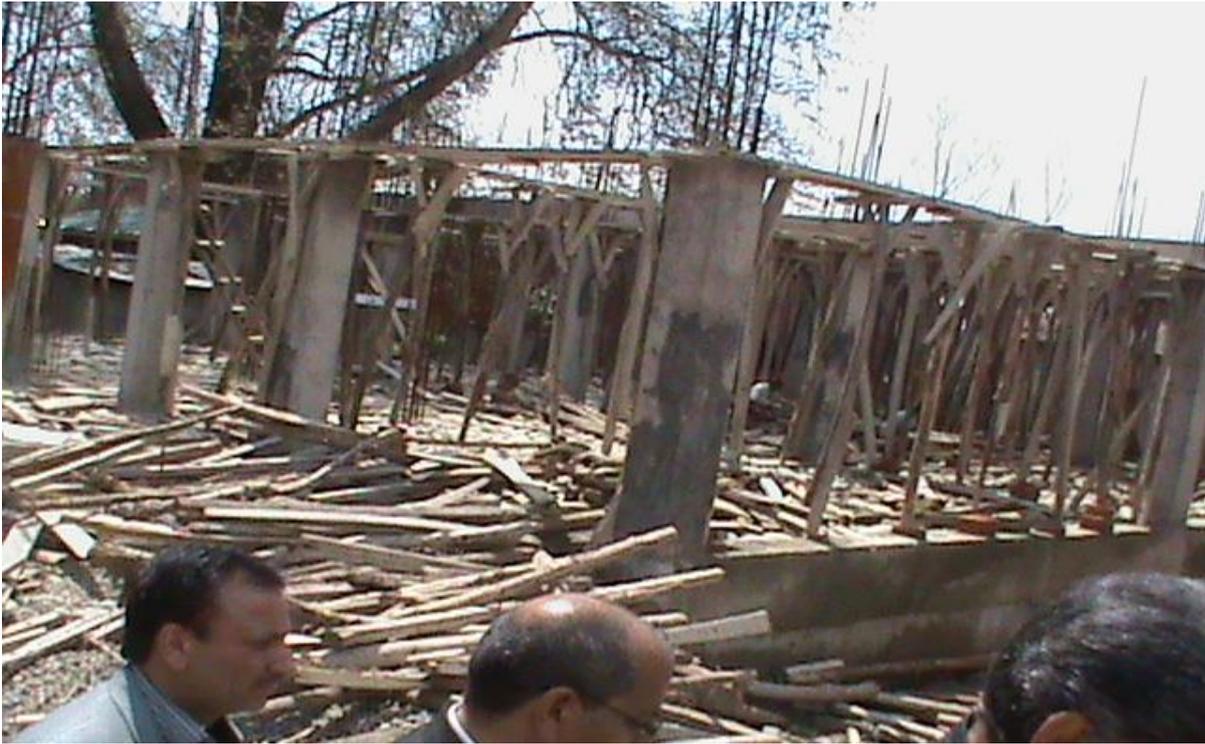
So far as the physical progress of this component of work is concerned, the column structures have been erected for ground floor and the shuttering for laying of slab is under progress.

Under construction Administrative block

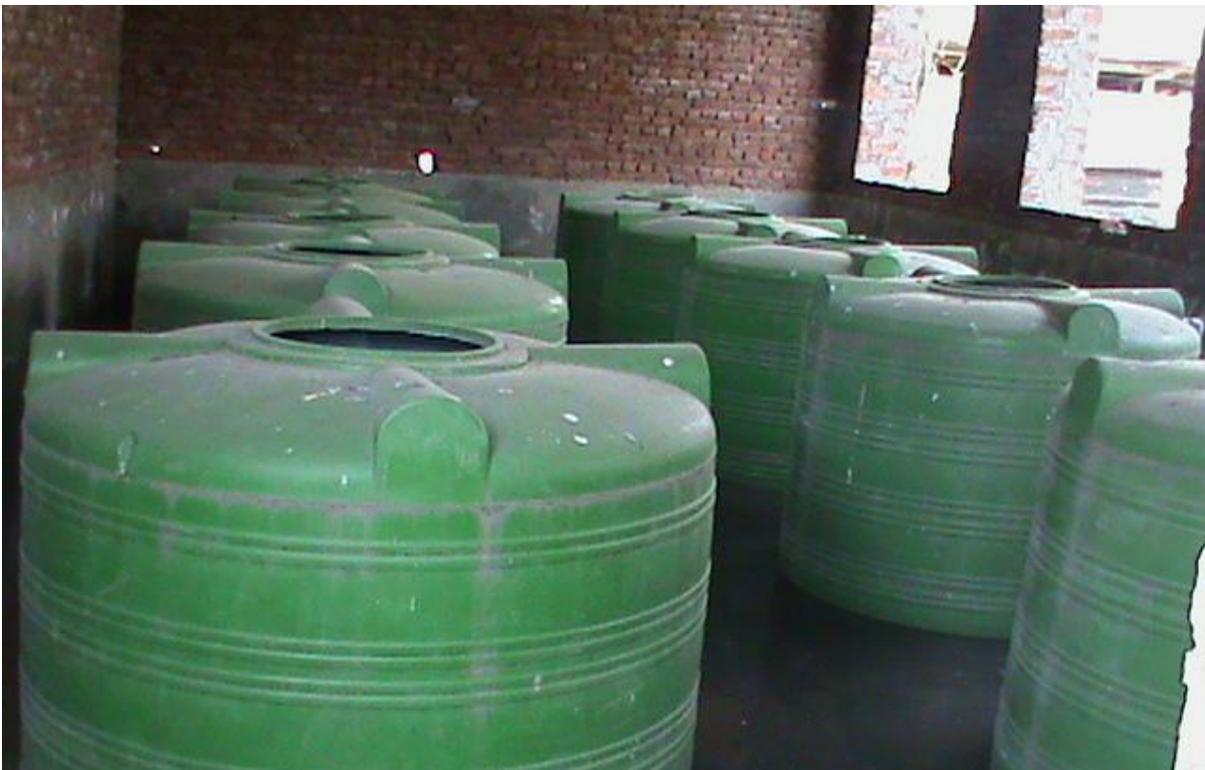
plea taken by the executing agency in constructing the above ground reservoir is that the water table in the area where the building is located is always high and, therefore, there was no alternative other than constructing the above ground reservoir. The walls of the structure are yet to be plastered from inside and also the window and door frames and shutters are not fixed.

Unplastered walls of structure for water reservoir with uncovered PVC tanks
