Physical verification report of the project namely
"CONSTRUCTION OF ITIs AT BANI & BANIHAL"
District Kathua & Ramban

By
Deputy Director,
CM's Monitoring Cell.

1. Name of Projects: Construction of ITI buildings at Banihal and Bani.
2. Funding Agency: Gol (PMRP).
3. Executing Agency: R&B, J&K.
4. Year of Start: 2011-12.
5. Year of Completion: 2012-13.

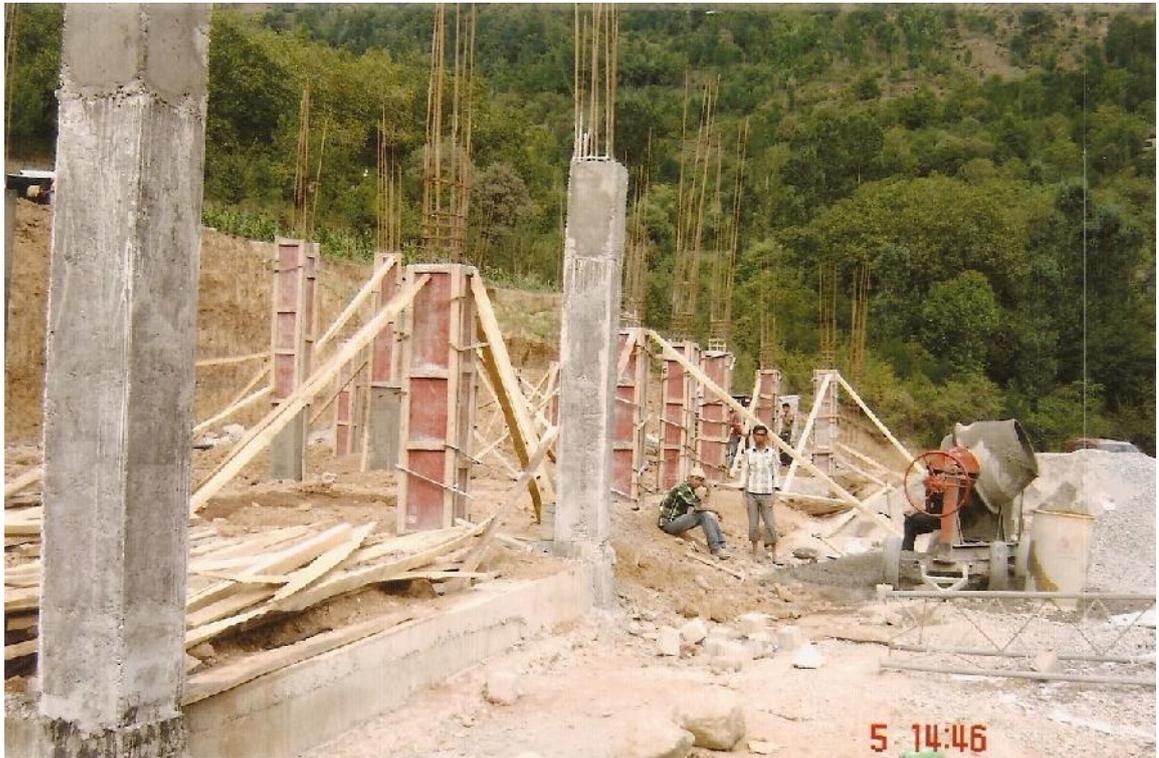
On the day of inspection it was observed that construction work of the main building which would be a double storey structure, has been taken up. Re-enforced concrete (RCC) foundation of the building has been laid after taking into consideration the recommendations put-forth in the soil testing report. RCC columns are being erected at the desired locations on the foundation as per the drawings provided by the architect/ consultant. The length and breadth of the outer foundation were measured to calculate the plinth area of ground floor which was found to be inconsonance with the drawing/ design of the building. However, while going through the DPR it was noted that the building has been approved for construction of a load bearing structure and not an RCC structure. On enquiry, the engineers of R&B Division Ramban informed that a column and beam structure had been preferred over a load bearing structure on the advice of the architect/ consultant. The contractor also informed that although the work was tendered for a load bearing structure, the construction was taken up as an RCC structure which has increased the cost of construction.

RCC columns raised over foundation of ITI Banihal

- a. Public Works (R&B) Department needs to re-examine and also intimate this office if there is sufficient justification to construct a column-beam structure of the ITI building Banihal and a load-bearing structure of the ITI building Bani when the design of the structure is same at both the locations.

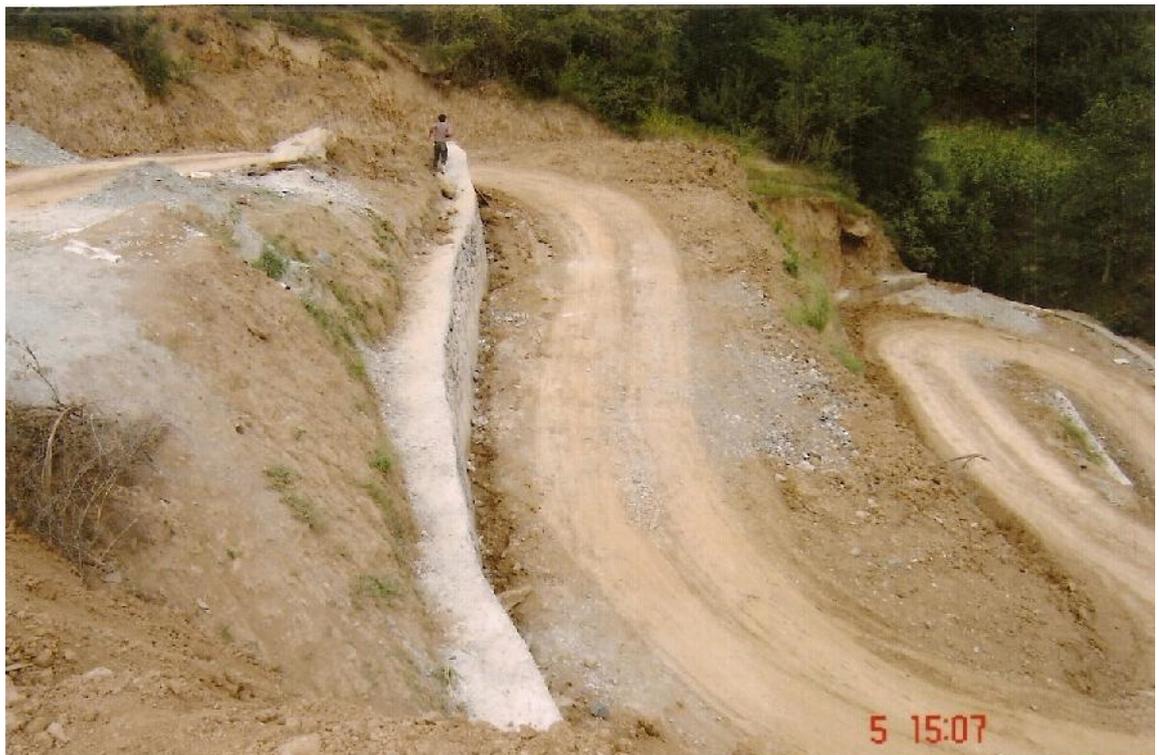
The earth work of the approach path to the ITI building which is about 200 meters in length is almost 90% complete. Retaining walls have been erected along the slopes to provide necessary strength and support to the approach road.

Earthwork of approach road to ITI Banihal

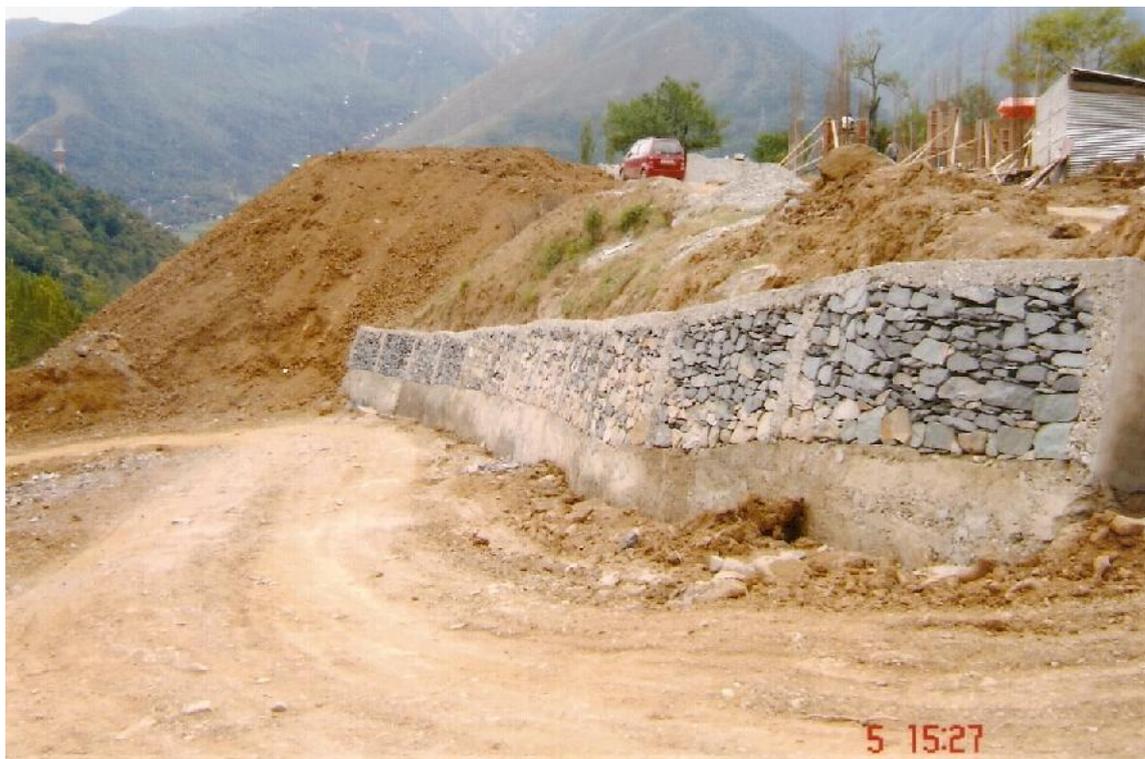
Retaining wall along approach road to ITI Banihal

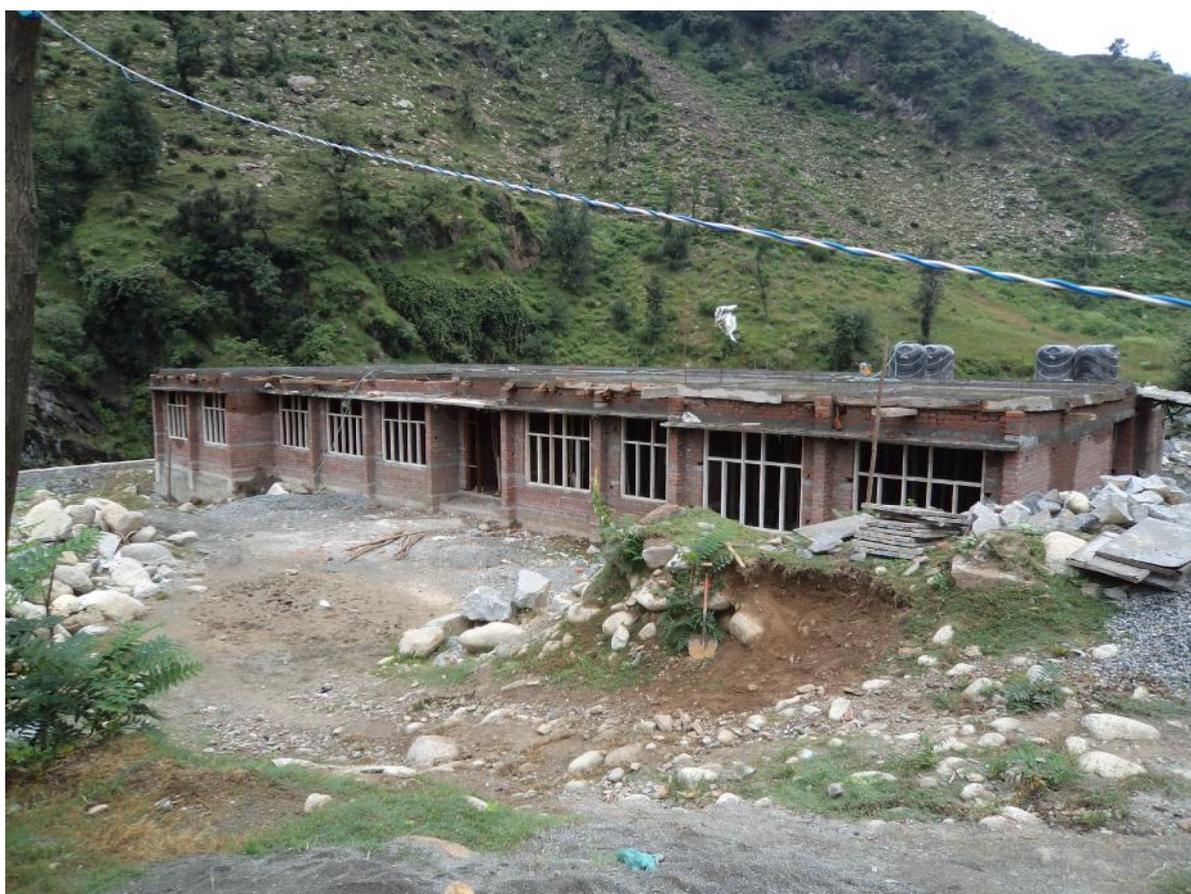
The construction work of the main ITI building taken up 4-5 months back is in progress. On the day of visit it was observed that the concrete lentil has been laid over the ground floor of the structure. The structure being constructed at Bani is a load bearing one and not RCC structure as observed at Banihal. The rooms in the ground floor were found to be as per specifications.

Ground floor of ITI Bani completed upto slab level

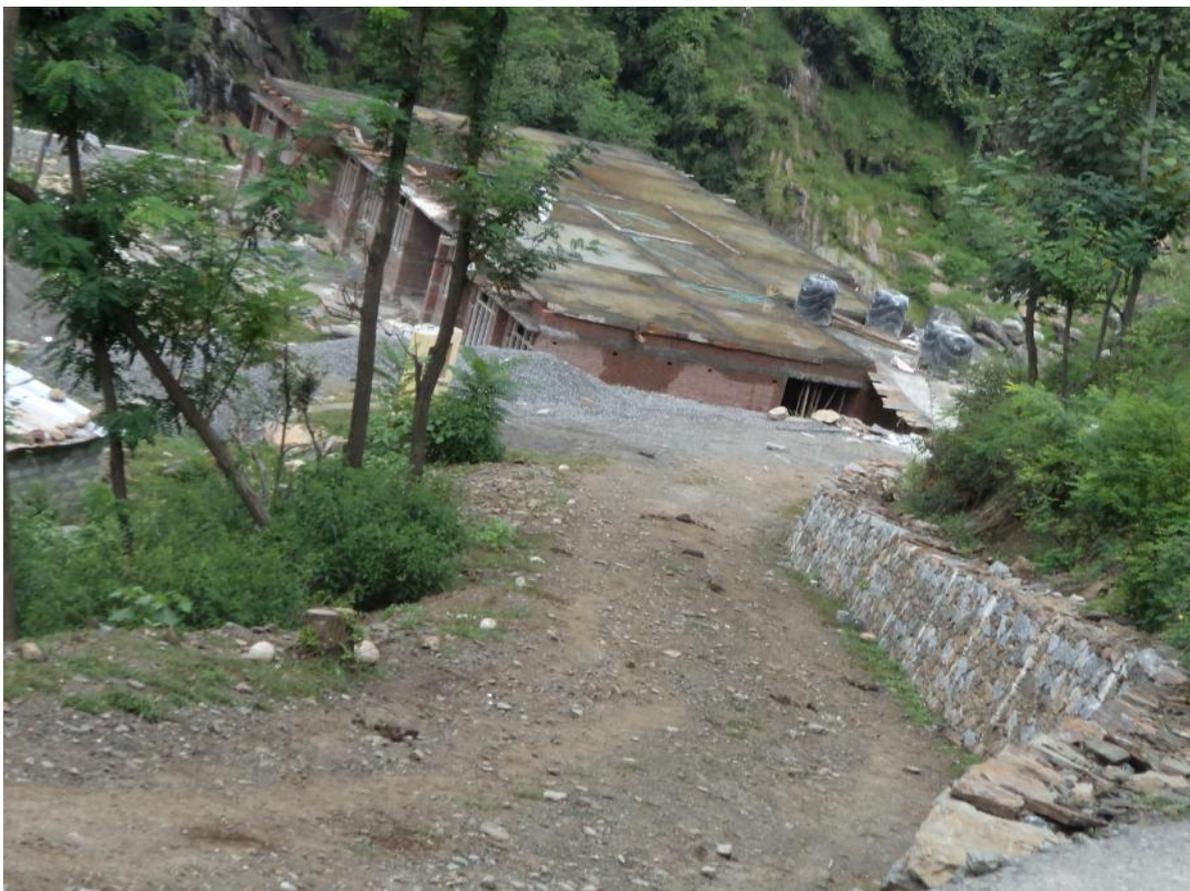
The earth work of the approach path to the ITI building which is about 30 meters in length is in progress. The gradient of the approach path from the road to the low lying terrace along the nallah on which the ITI building is being constructed was found to be steep. The engineer of R&B Division Bani informed that one of the locals from whom the land had been acquired has encroached into the acquired area as a result of which sufficient space is not available to construct an approach path with lesser gradient. He further informed that the issue has been brought to the notice of Technical Education Department many a times but their correspondences in this regard have not been responded to till date.

Steep gradient of approach path to ITI Bani

- h. Technical Education Department needs to have the land acquired for ITI Bani demarcated once again through the Revenue authorities in order to take over the possession of the entire land with the assistance of district administration, if necessary, so that the issue raised by the executing agency regarding encroachment of a portion of the acquired land a local is resolved. This issue when resolved shall help in changing alignment of the approach path thereby reducing the gradient of the existing steep approach path.

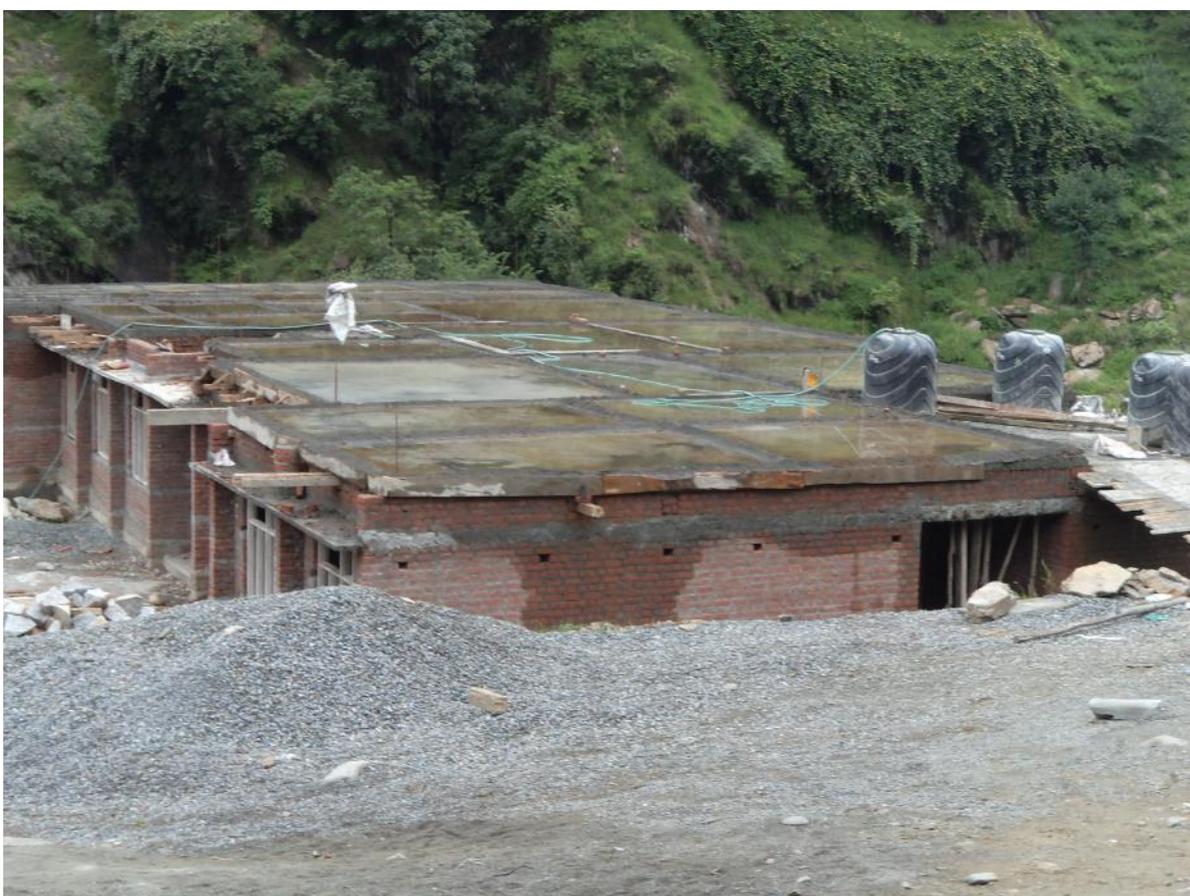
Watering of slab of ground floor of ITI Bani
