GOVERNMENT OF JAMMU & KASHMIR  
Chief Minister's Monitoring Cell

Physical verification report of the project namely  
"Construction of New Type Primary Health Centre  
at village Batpora-Magam, Handwara, District  
Kupwara

## PHYSICAL VERIFICATION REPORT

Name of the Project:	Primary Health Centre at village Batpora-Magam, Handwara District Kupwara
Source of Funding	State Plan
Executing Agency	JKPCC Ltd
Year of start of Work	October 2004
Original target date of completion of the project	October, 2006 (two working seasons subject to availability of funds)

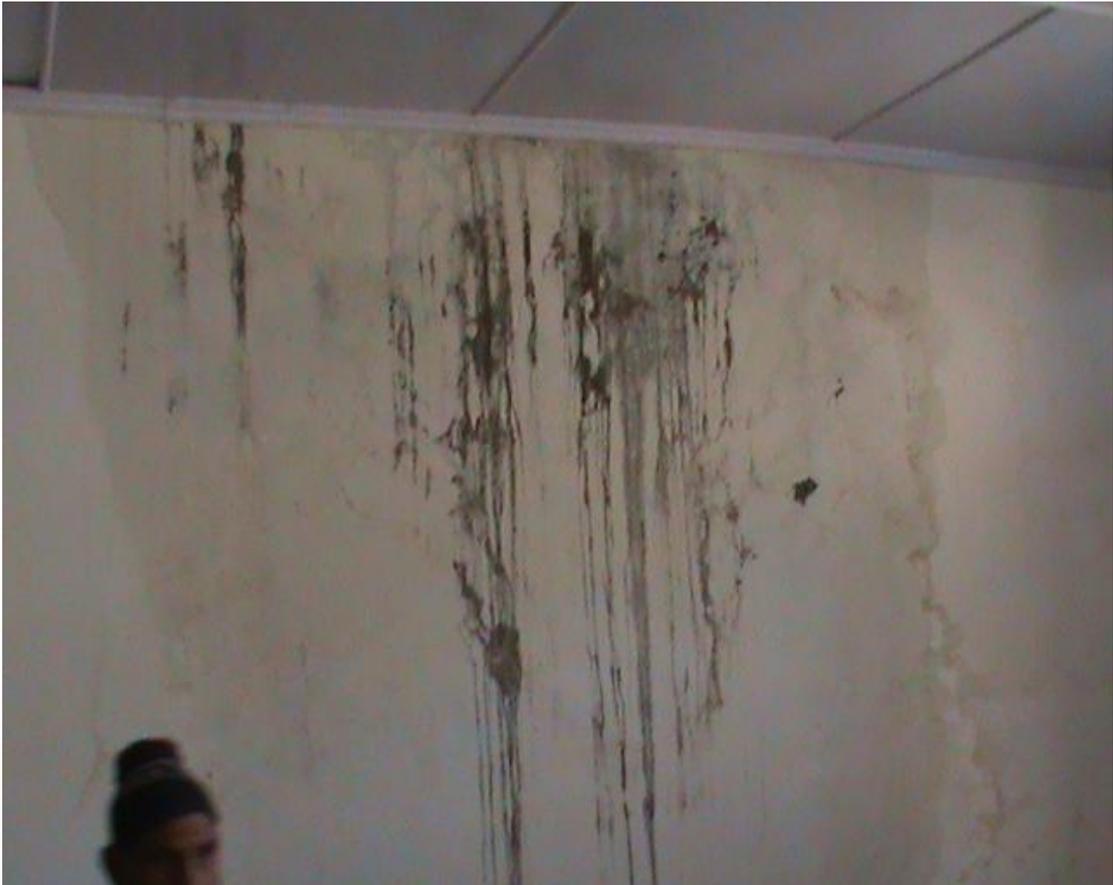
There is water seepage in the walls of the rooms housing General Male ward and Female ward. This seepage is as a result of leaking of the water pipes fitted to the storage tanks installed on the top floor of the building under roof. The walls have become quite shabby besides suffering damage and the leakage/seepage was found even on the day of inspection. On enquiry the Manager JKPC assured that immediate remedial measures would be taken to overcome the leakage problem.

Water leakage/seepage in the walls of PHC

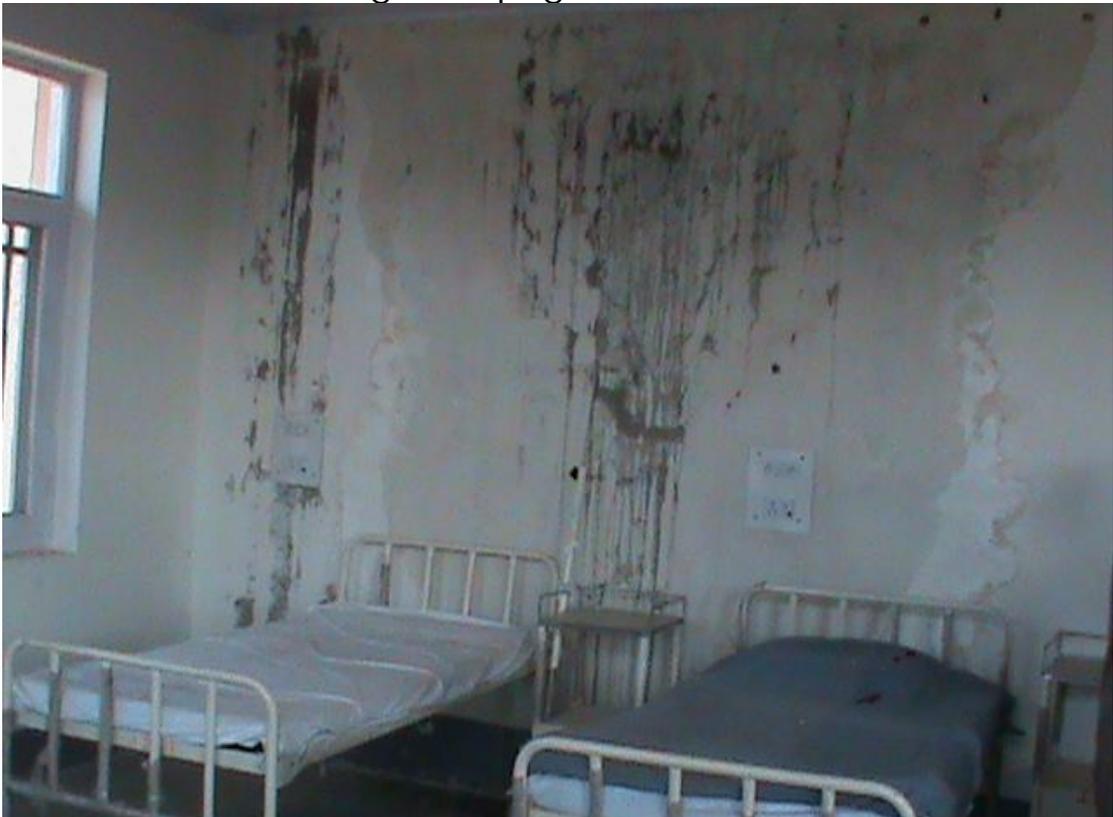
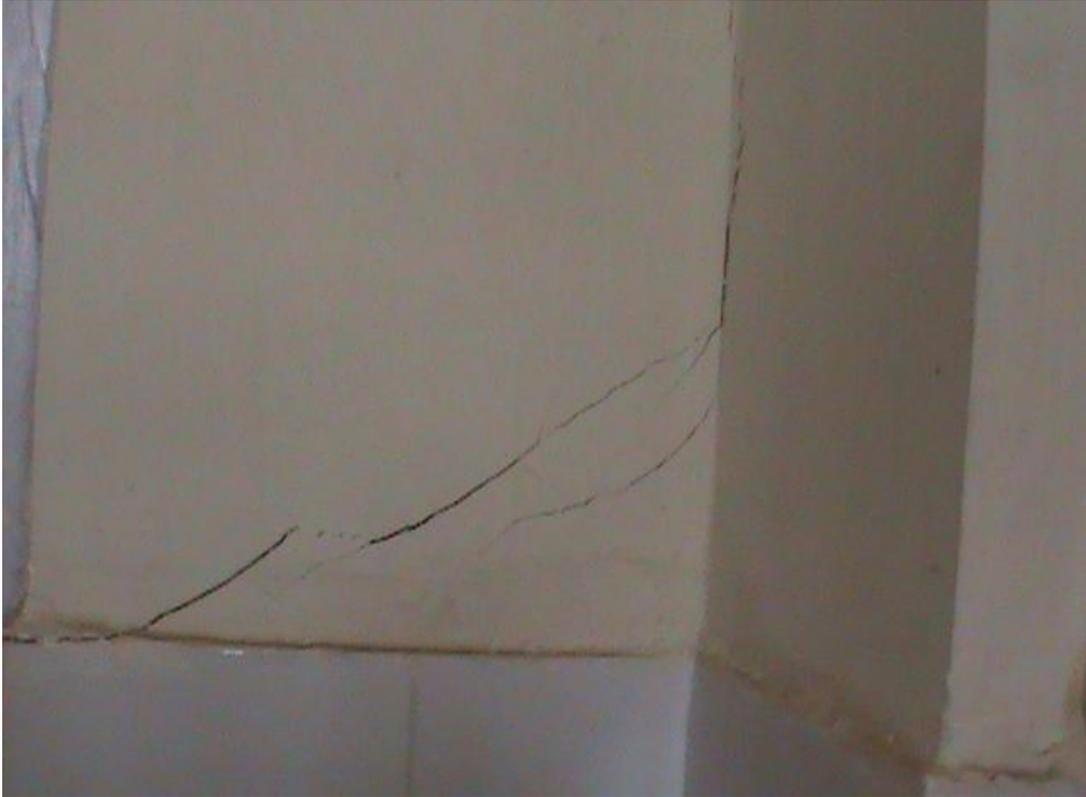
The building has developed numerous cracks from outside and inside as well which are quite visible from a distance. However the cracks are bigger and wide at certain spots on the inner side of the PHC which seems alarming. On enquiry it was explained by the Project Manager that the cracks have developed as a result of vibration caused by the movement of the machinery within the premises. But the plea taken by him was not found convincing and reasonable because the construction has taken place on a hill toe where the earth can be considered to be stable one. The impact of the crack in the toilet point is such that even the tiles fixed

on the wall have cracked with the crack in the wall. This gives an impression that either the substandard material has been used in construction or there has been lack of supervision on the part of engineering staff during its execution. However it was assured by the Project Manager that the faults would be corrected very shortly but that would not serve the purpose as the repairing of the outer surfaces cannot correct the basic fault of cracks. If the cracks are deep inside then the building is not going to withstand for a longer period of time.

Cracks developed in the walls of the PHC

The authorities should institute an inquiry by way of a constituting a team which should comprise of capable and honest engineers for ascertaining the reasons as to why and how there have been cracks in the building immediately after its completion and use. If the cracks are as a result of using substandard material or lack of

supervision during its execution the responsibility of the officers' may be fixed by way of serving them with the punishment of highest severity so that a deterrent is created for others in future for such lapses. Further it is suggested that the repairs to be carried out on this account should be at the cost of the salary of the engineering staff who were supposed to supervise the construction of the PHC and if attained superannuation then from their pension dues.

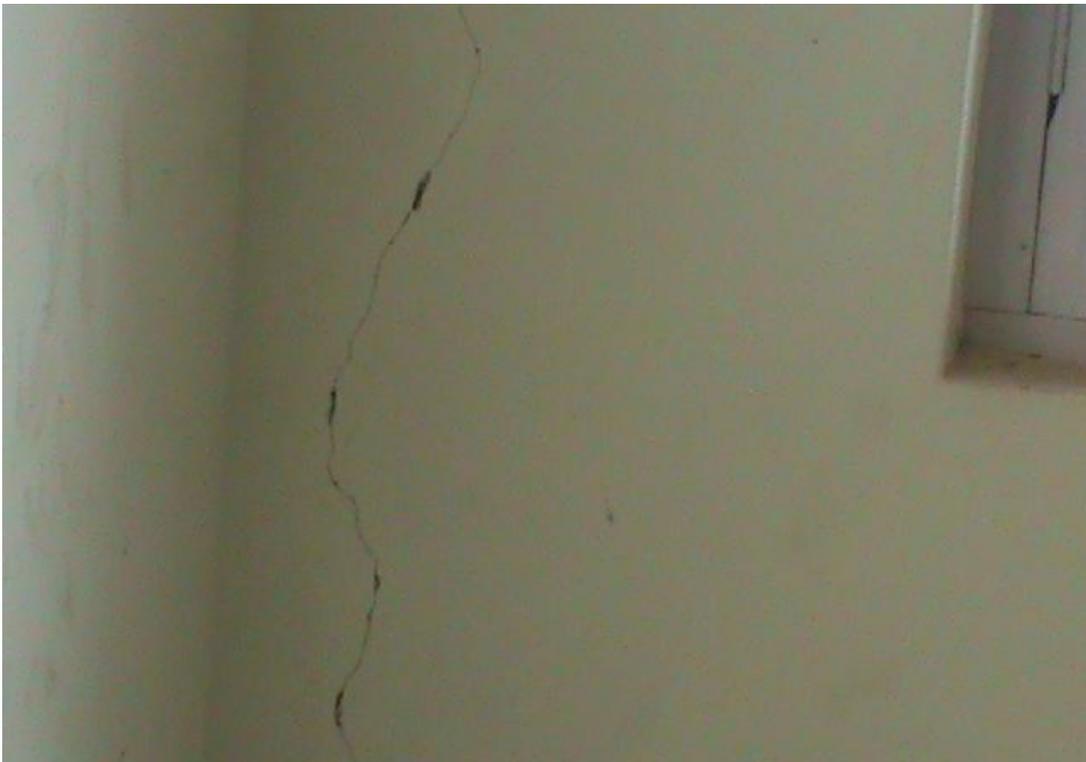
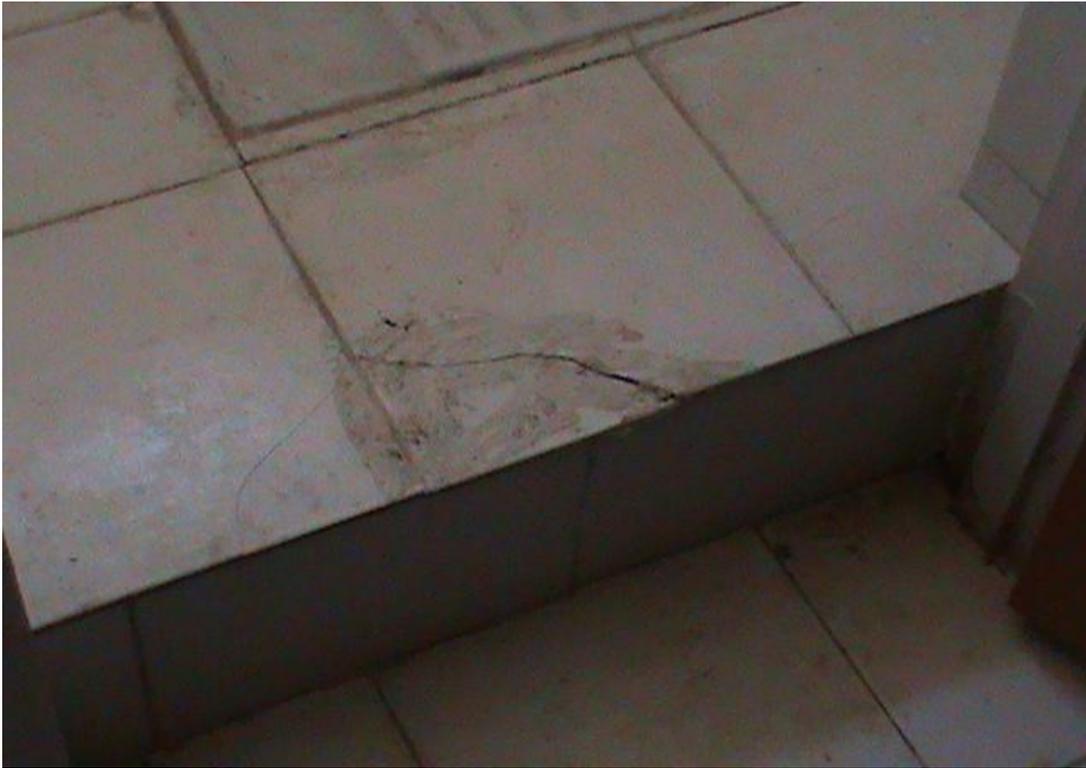
Cracked/broken tiles in the toilet points

Immediate steps need to be taken by the executing agency for release of the choked outlet pipes of the toilet points and catchment drain of the retaining wall, replacement of broken tiles, repairs/ proper levelling of the ceiling in some rooms and carrying out other repairs wherever required.

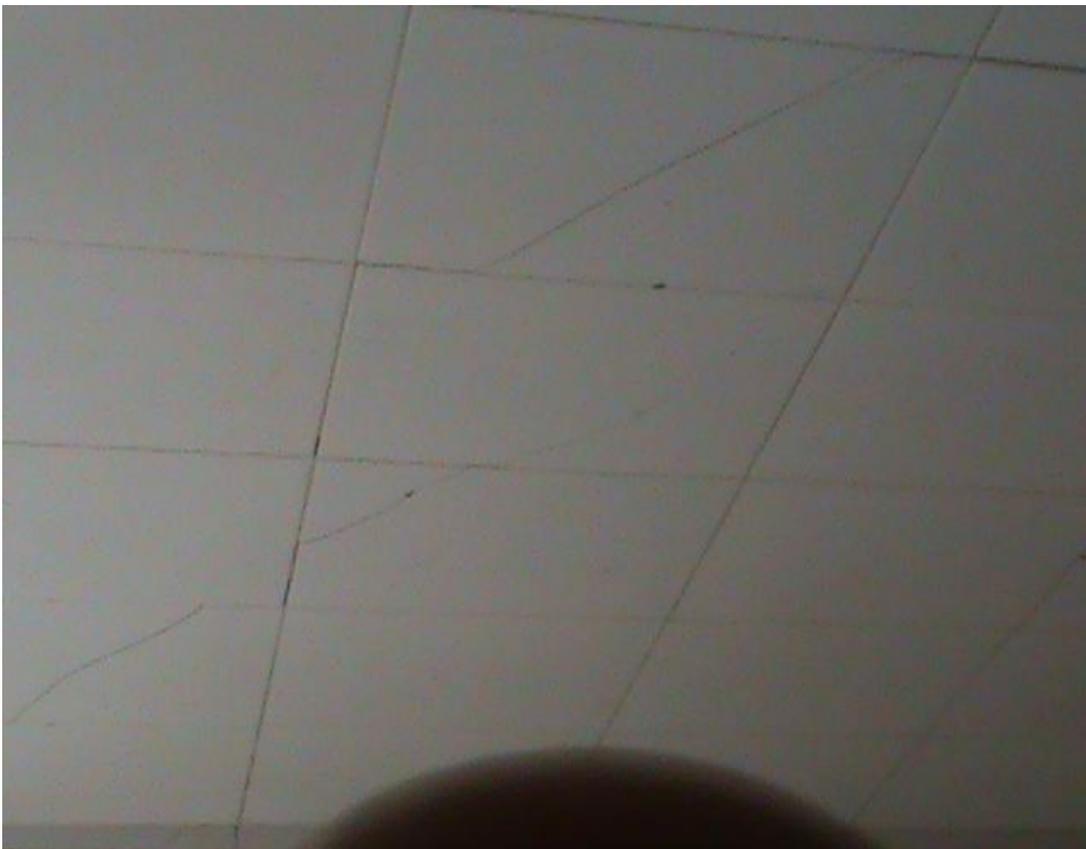
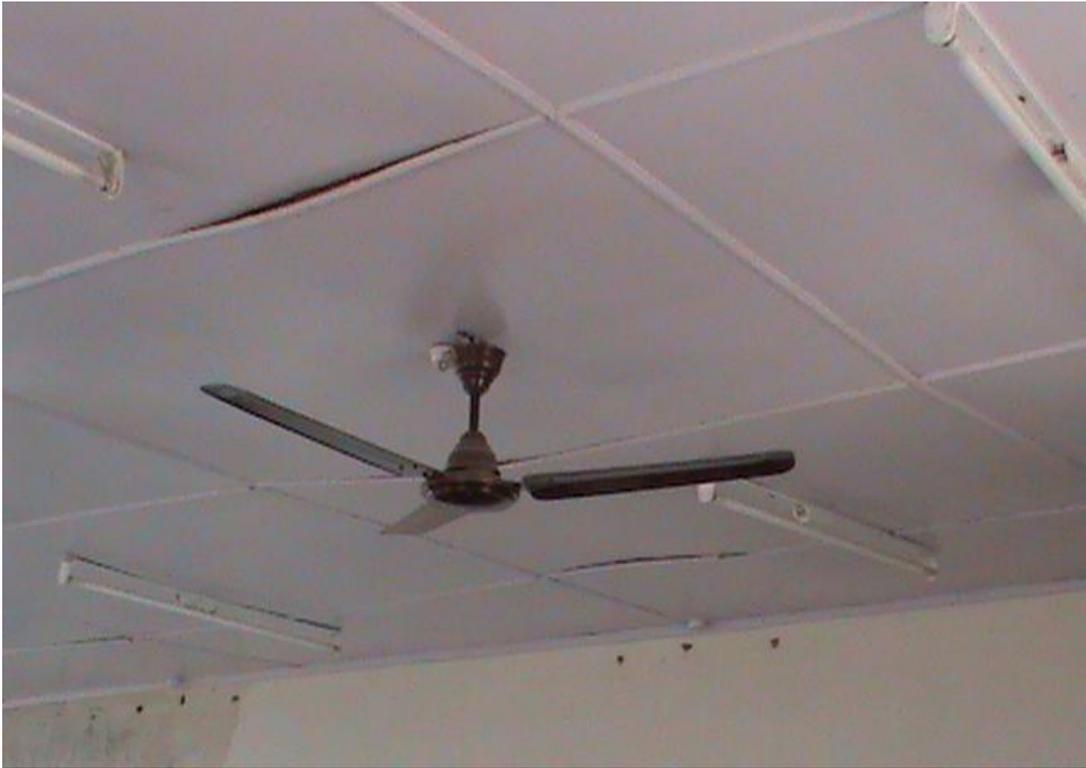
The workmanship quality in fixing of the ceiling provided in the first floor (top floor) was not also found satisfactory. In some rooms the ceiling has not been levelled properly which gives again an impression that the execution for this part of work has been carried out in a perfunctory manner. Further it is apprehended that standard material has not been used for execution of this item of work but this aspect needs to be verified by a technical person.

Lack of workmanship quality in fixing of the ceiling

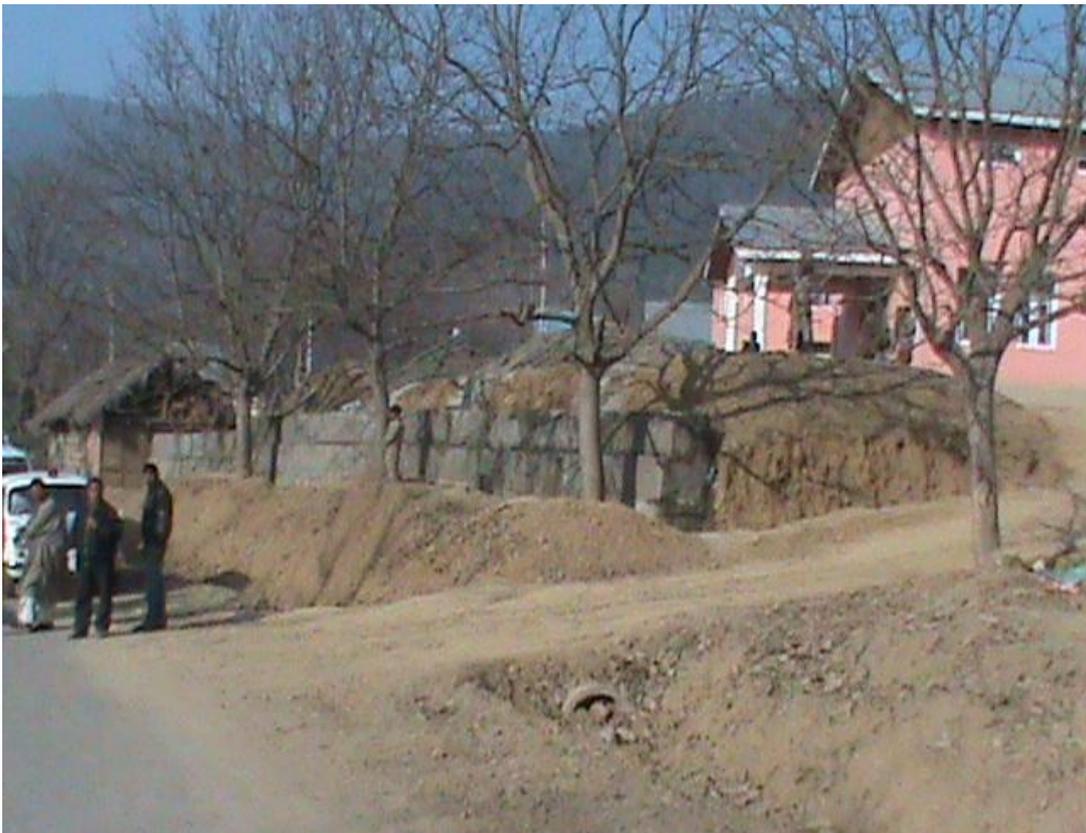
Fair-weather approach road to PHC

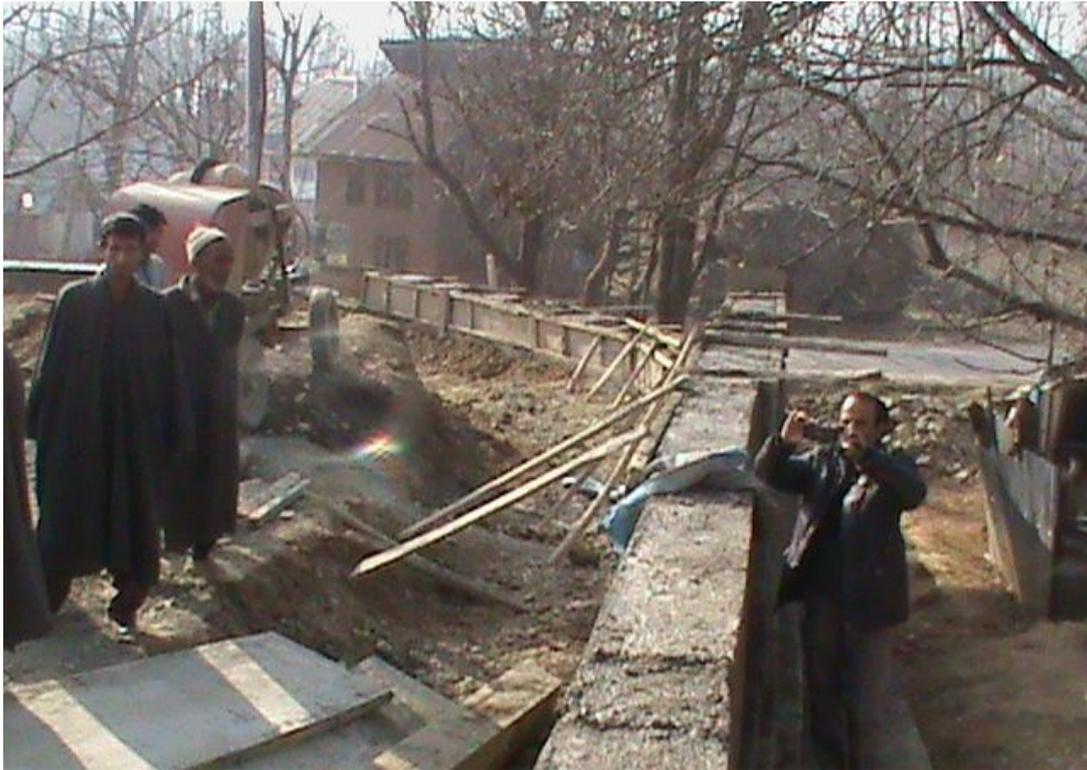
The retaining wall on backside of the PHC has also been completed and the work on the other three sides of the boundary wall was found under progress by way of laying of cement concert blocks which is being executed through R&B Div Handwara under NRHM.

Laying of cement concrete block for boundary wall of PHC under progress

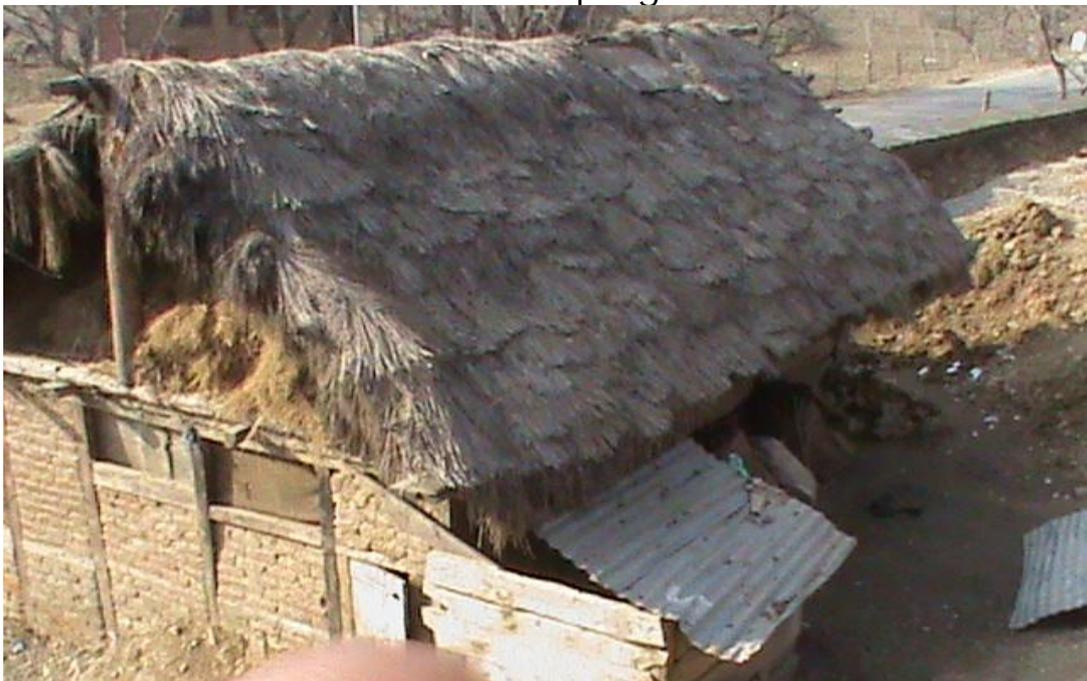
There is a temporary house structure of one namely Shri Gh Rasool Bhat which is coming in the way of the boundary wall of the PHC presently under execution. This structure has been constructed by him long back and he has reportedly no land anywhere of his own where he could erect his house structure and as such will get displaced as a result of this construction. The person being financially very unsound, pleaded for allotment of a small piece of state land with financial support under IAY for construction of his residential house.

Temporary house structure coming in the alignment of the boundary wall of the PHC

The district administration can consider accommodating Shri Gh Rasool Bhat under IAY for construction of his residential house on kacharai /state

land who is likely to get displaced as a result of the construction of the boundary wall of the PHC.
