GOVERNMENT OF JAMMU & KASHMIR  
**CHIEF MINISTER'S SECRETARIAT**

Physical Verification Report of the project namely

***“Construction of Haj House at Bemina, Srinagar”***

By Joint Director,  
CM's Monitoring Cell

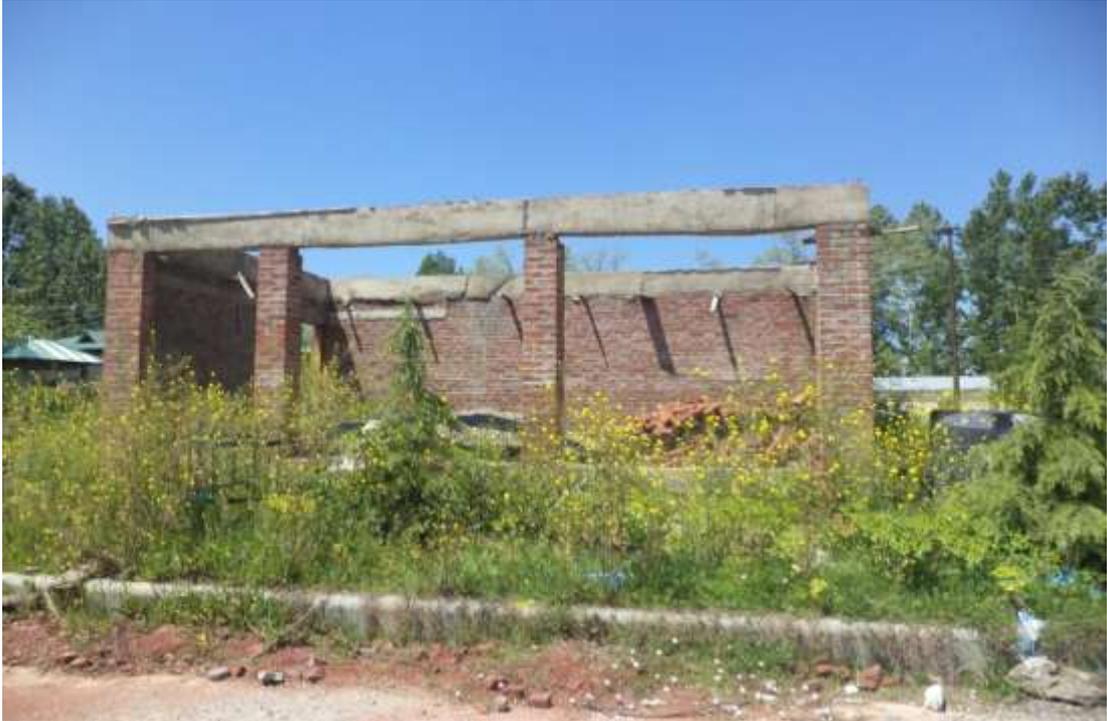
The construction of Market / Health Centre has been abandoned midway leading to denial of medical facilities to the pilgrims. This building block has been completed upto roof beam level only.

Abandoned Market/ Health centre in Haj House complex

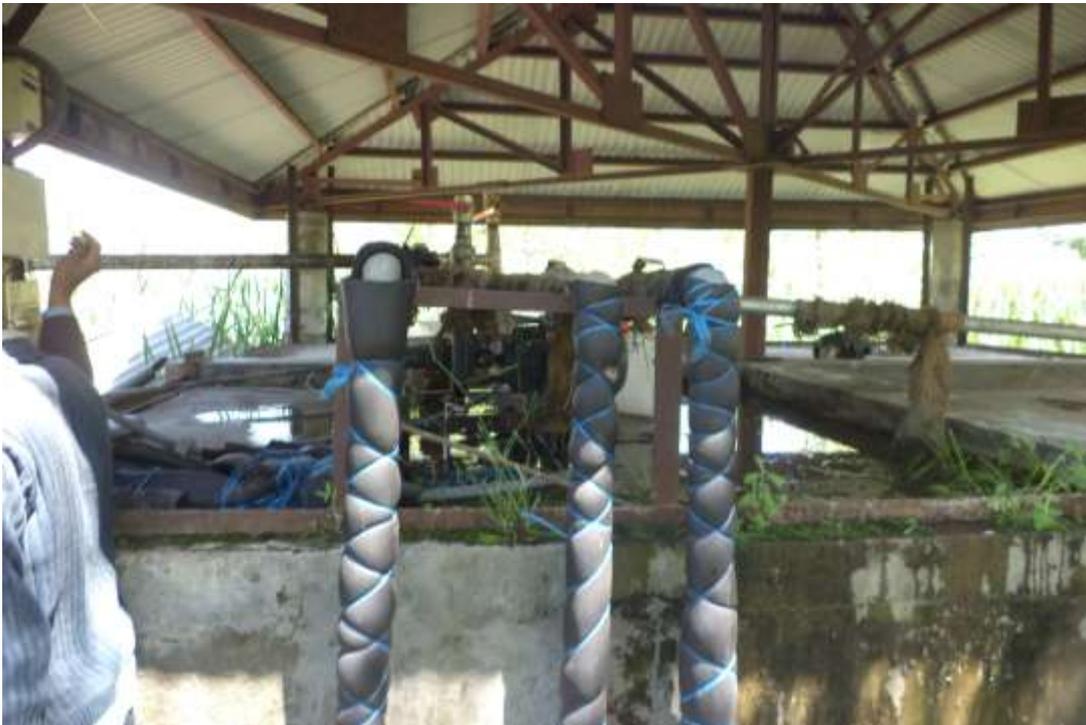
As provisioned in the cost offer, water sum of a capacity of 50000 ltrs was to be constructed but the same has been constructed for storage of 12000 ltrs only in the backyard of Hajj House complex. It was informed by the executing agency that sump with low capacity has been constructed on the basis of water requirement within the premises. Therefore the savings on account of the construction of sump with lesser capacity may be available with the executing agency. This reservoir is roofed with plain CGI sheets for safety purposes. The water reservoir has been constructed in such a way that half of its portion is underground and half above ground. The area around the reservoir is water logged. Under the circumstances, there is an apprehension of seepage of accumulated contaminated water in the tank/ reservoir which can prove detrimental to public health.

The water reservoir and cement concrete platform for AVR appears to be constructed at inappropriate places. These two components of work have eaten up the vital of the land of the premises. These units could have been constructed in the backyard corner of the premises for saving the land/ space for future expansion of Haj complex.

Water sump with capacity of 12000 Ltr constructed within the complex

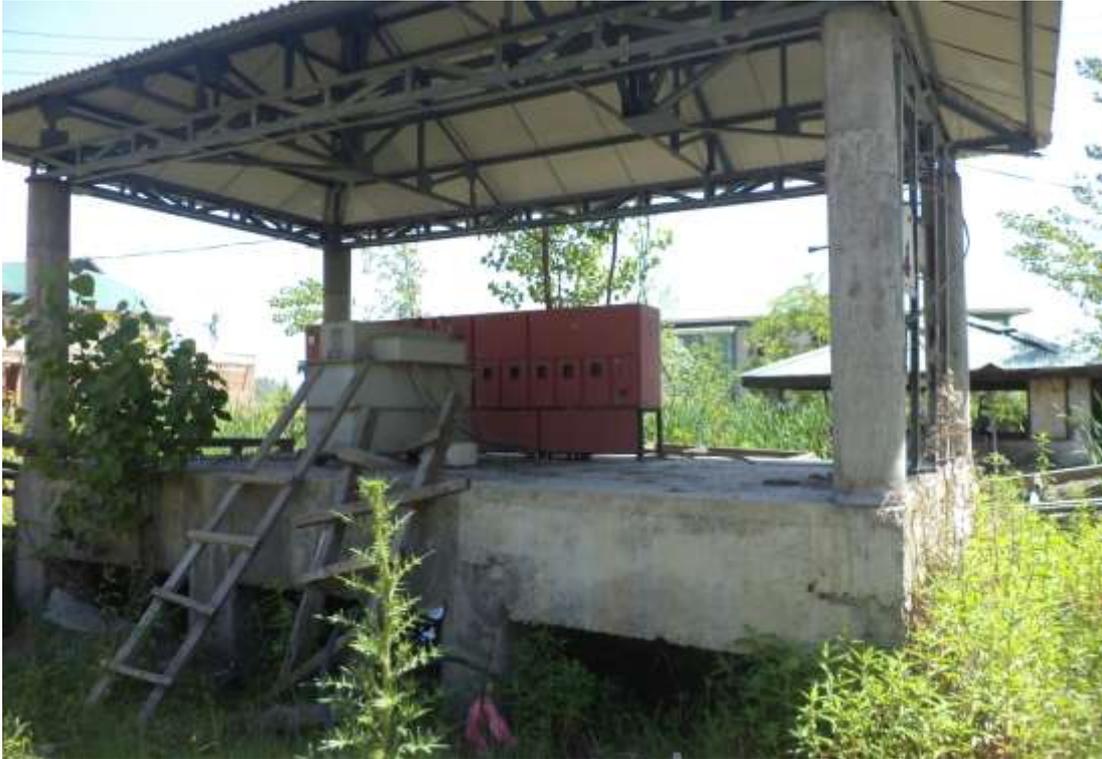
It was also noticed that an AVR stands installed on a cement concrete platform in the backyard of the complex for providing uninterrupted power supply to the Haj House complex. The said platform has not been covered from sides. More dangerously, the electric cables provided for electric control plant were found in water. There is apprehension of electric short-circuit which may lead to an untoward incident of loss of human lives and damage to the property. Under the circumstances there is immediate need of realignment of the electric cables connected to the AVR.

Installation of AVR (63 KVA capacity) within the premises with cables floating in water beneath the platform

- The executing agency should firm up the cost estimates after taking out the cost of Departure Lounge of ` 1.77 crore from the cost offer and submit the same to Competent Authority for accord of approval.
- The Competent Authority could consider release of the balance funds during the current fiscal for closure of the project.
- The executing agency should take-up left over work of construction of Health Market, Services block, Plant room etc. It should also ensure rectification of errors in civil and electrical works noticed within the building blocks.
- The executing agency should plug the gaps of bird entries in soffits of the buildings. It should also carry out the work of realignment of electric cables connected with the control panel of AVR to prevent any untoward mishap.

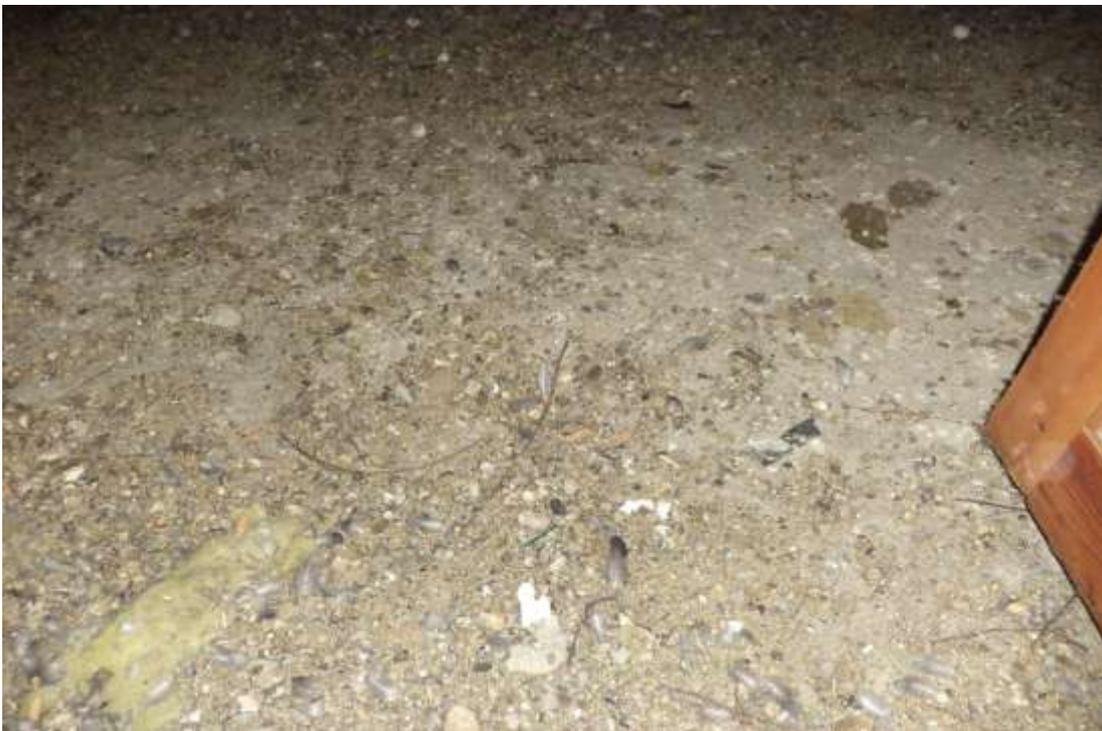
It was informed that thin plywood sheets have been used in the soffits of the building blocks. But these ply sheets have developed cracks which has resulted in gaps at certain spots. The birds manage their entry through these gaps and have made nests inside the buildings under roof tops. This proves to be a big nuisance as the surroundings and interiors of the buildings were found littered with bird droppings, feathers etc. It was reported by the Executive Officer, SHC that several requests were made to the executing agency to seal the gaps but the same did not evoke any response until now. But the officials of JKPCCC informed that the plywood fixed in the soffits has the tendency of breaking down given its strength and the provision of replacing the thin ply sheets already fixed with comparatively thicker plywood sheets is not in the cost offer. They however, assured that necessary measures will be taken to seal the gaps in soffits at the earliest.

Floor littered with bird droppings and feathers within the building

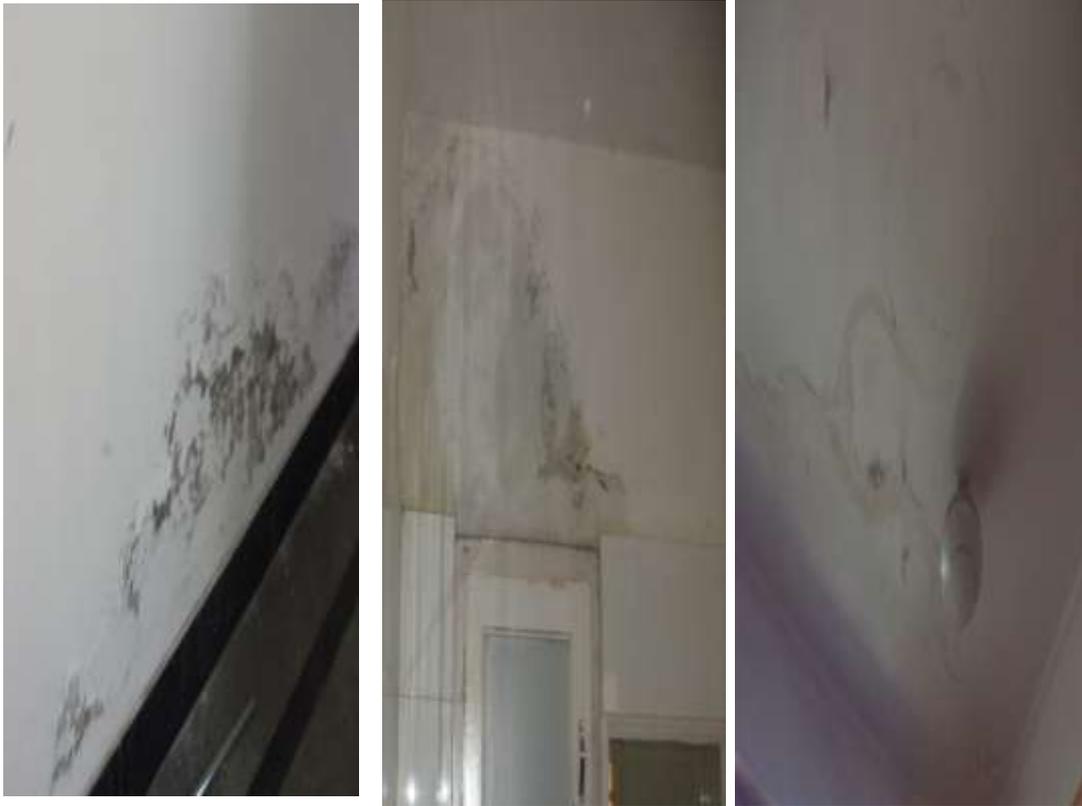
He (EO) further said that PoP covering had developed cracks in some rooms. In the past the PoP cover of meeting hall, prayer hall and some portions of corridor cracked and crumbled down which subsequently was repaired by the executing agency. Recently one of the room in the ground floor of office block also had a similar problem, which was again reported to the executing agency.

However, it was noticed that the executing agency had undertaken the repair work of cracks in the PoP ceiling but no attention was paid to the damages/ leakages in the bathrooms with the result the bathrooms had to be closed for some time.

Damaged/ cracked PoP Ceiling in few of the rooms in building blocks

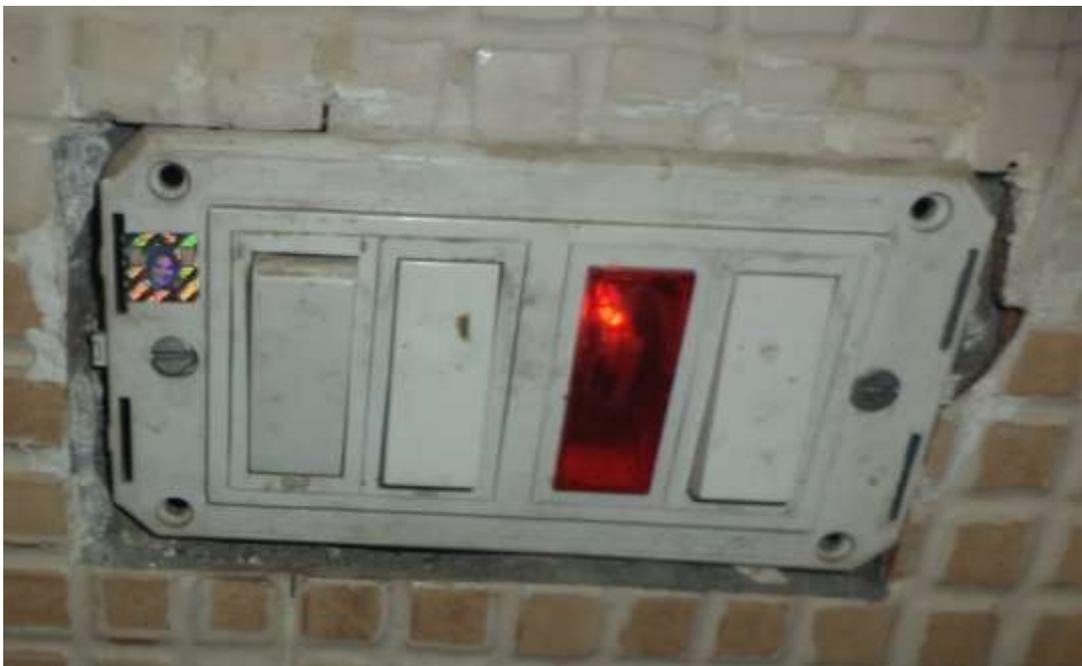
Sofar as electrification is concerned, inspection boxes have been provided at all required spots. During inspection it was observed that electric switch plates have suffered damages at various places. On enquiry it was revealed that the damages to the switch plates have caused because of improper use of heating points by the staff coupled with non maintenance of appliances. However the DGM assured to replace the damaged electrical fixtures. The electrical fixtures of quality brands like "Philips", Ceiling fans of "Crompton Greaves", lighting accessories of "Philips" make have been fitted. Quality sanitary/ CP items of "Jaguar" make and other accessories of "Prakash" have been fitted/ installed in the building blocks at the required places.

Damaged electric switch plate in one of the rooms of CFC building

- The SHC could consider hiring the services of plumber/ electrician for maintenance of the sanitary and electrical appliances within the building blocks etc. It could also consider renting out the Residential Block of Haj House for holding social functions like marriages etc during lean period for generating revenue which could be utilised on the maintenance of Haj complex.

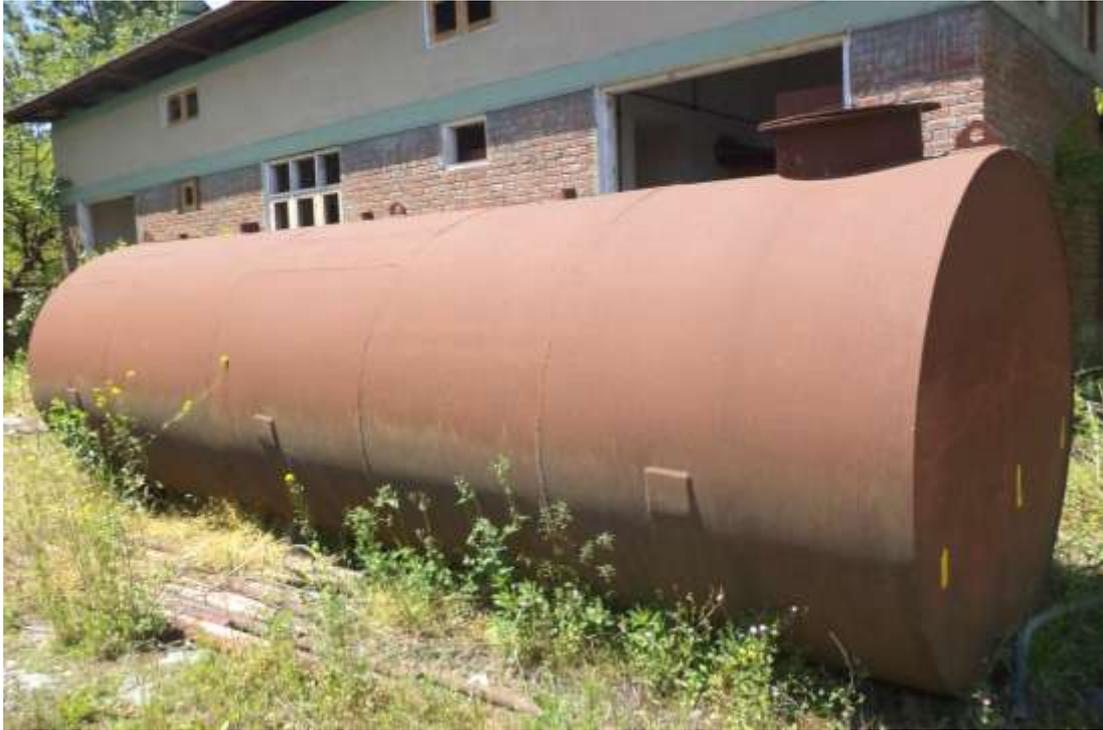
The component of Central Heating System (CHS) has been taken up at a cost of ` 65.00 lacs. The CHS is presently functional in Administrative block only. The mechanical components of the Central Heating System have been installed and fixed in the plant room but the civil works have been left halfway. Reportedly the civil works are pending due to non availability of funds. An iron oil tank for storage of oil was also seen grounded within the premises but the tank has gathered a lot of rust. The executing agency should immediately take up the painting work of oil tank for preventing it from further rusting and decaying.

Structure constructed for Boiler room and oil tank of 15000 ltrs capacity grounded within the premises.

- The executing agency should immediately take-up the painting work of the oil tank lying in front of plant room which is apprehensive of getting further rust. It should also take-up the remaining work of land development within the premises which has been left unattended to until now.

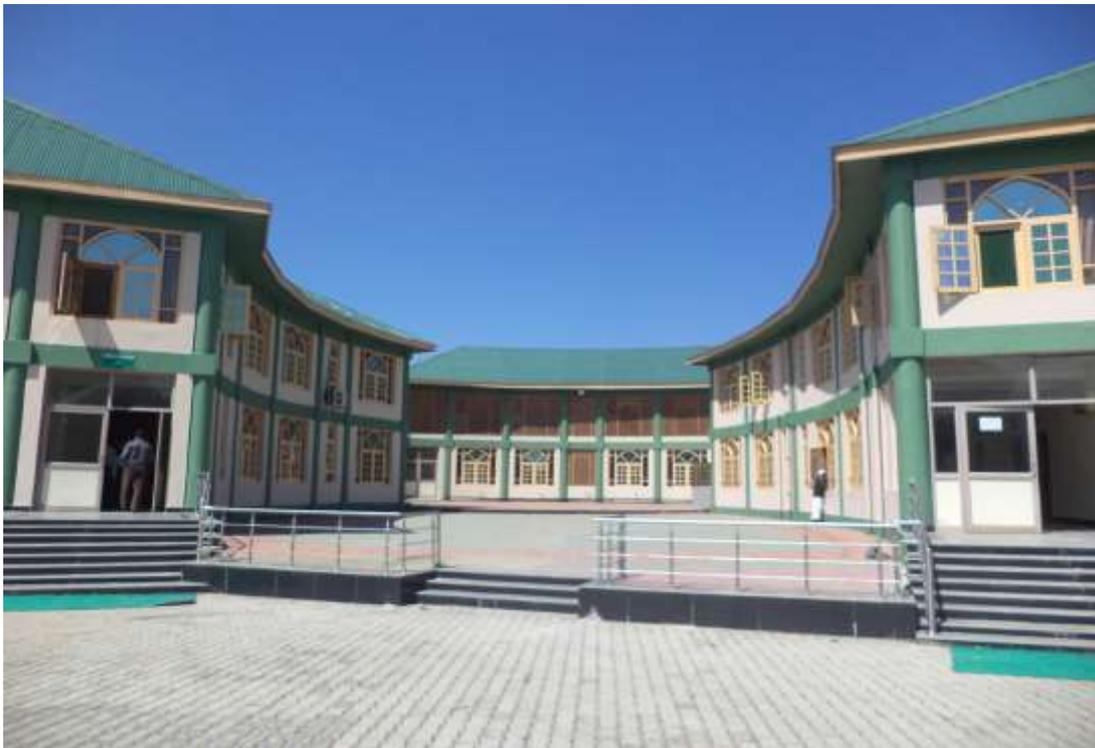
Ramps have been provided on entrance of Common Facility Centre, Residential block etc to facilitate smooth movement of people carrying heavy baggage on trolleys while moving around in premises from one block to another.

The main door frames are of Aluminium alloy in Reception Lounge and CFC. "Deodar" wood has been used in doors, windows and ventilator frames including toilet points inside the building block while as Kail wood has been used in shutters in Residential block and CFC.

Almunium alloy door frames and stainless steel railings provided/ fixed along ramp on the entrance of CFC

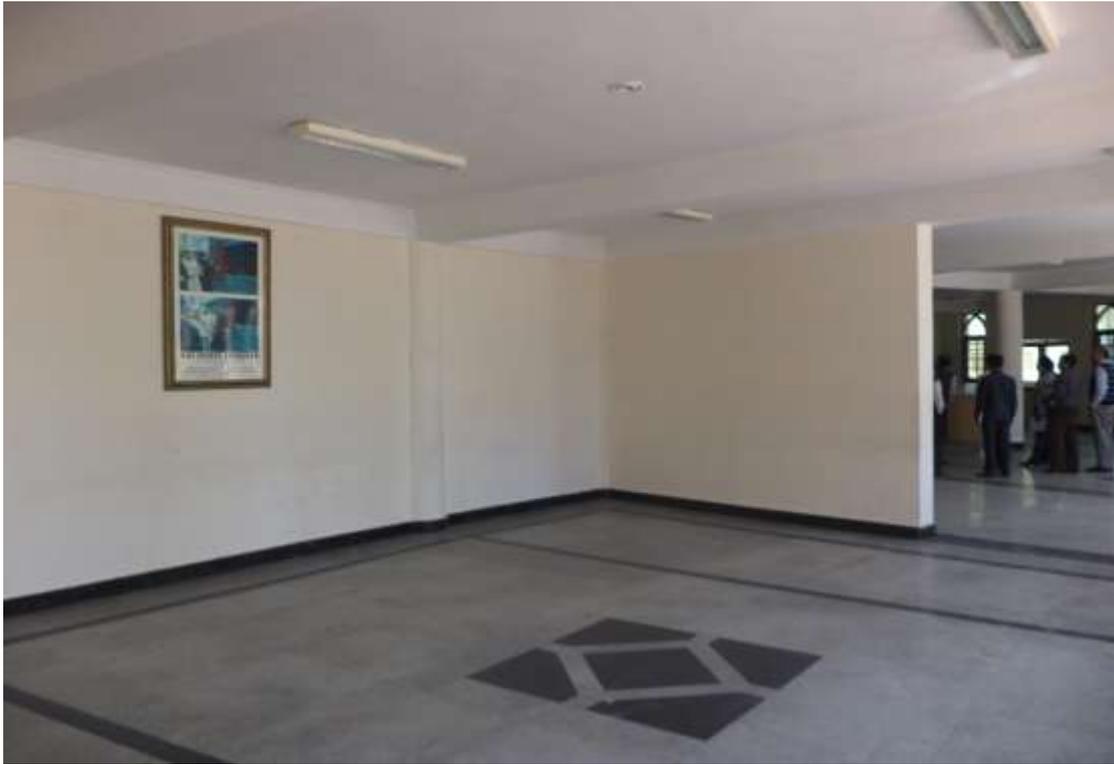
Granite flooring has been provided in circulation areas in ground floor while as vitrified tiles have been fixed in circulation areas of Reception Lounge and first floor and second floor of CFC and Residential block. Tiles have also been fixed in the toilets/ washing points with wall cladding upto 7 feet. Good quality granite stone has been used in the stairs. Stainless steel railings have been provided along stairways and other locations within the building blocks. The walls have been plastered and finished with white wash/cement wall putty.

Granite flooring provided in circulation areas of Ground Floor of CFC

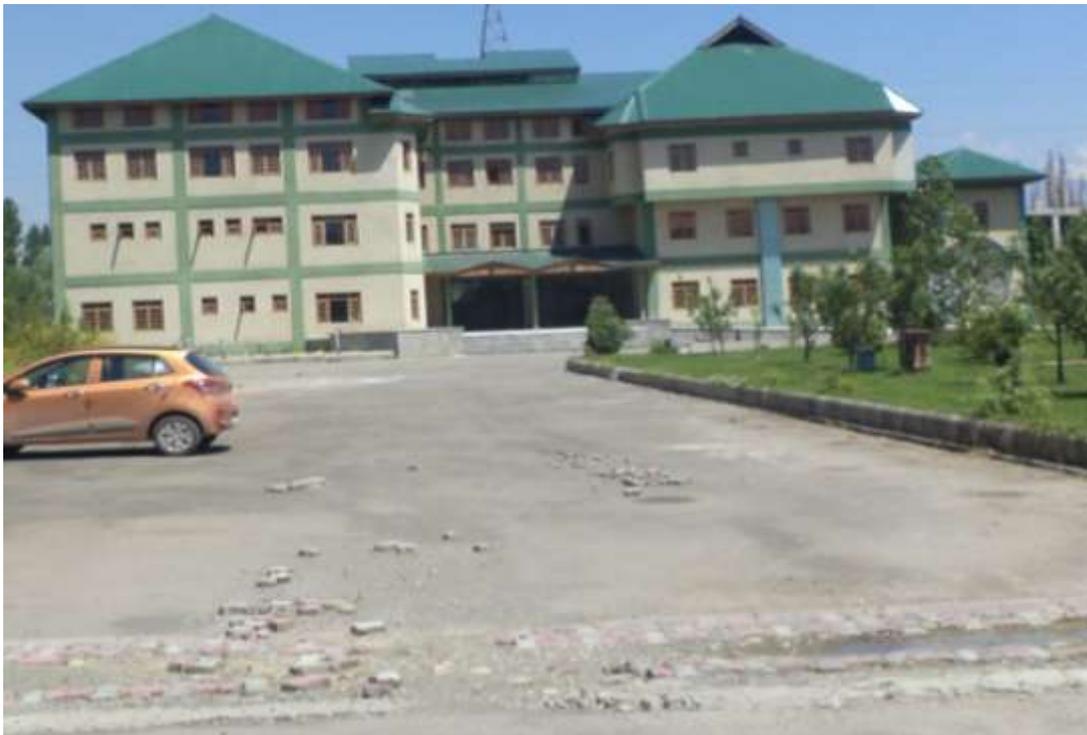
A boundary wall with ornamental/welded mesh of 1465 rft has been constructed around the premises. Tiles have been laid in the walkways for almost 1200sft. But the tile work has suffered damage at certain spots. The internal roads and the parking area of the complex have been macadamised. Besides this, surface drains have been also constructed to cater disposal of rain water etc.

The Residential block is a three storey RCC framed structure. This building block with attic floor can accommodate 246 persons (approx) at a given point of time. It has 13 Dormitories each having capacity of accommodating 16 single beds and 19 rooms with double occupancy, which includes 4 suites with attached bathrooms. The residential block stands completed in all respects but the elevator facility provisioned in the cost offer has not been provided as yet in the building block. However, it was informed by the DGM, Mechanical, JKPCC that the tenders for this item of work have already been floated.

Front view of Residential Block and portion of damaged walkway
