GOVERNMENT OF JAMMU & KASHMIR

Chief Minister's Monitoring Cell

**Physical verification report of the project namely
"CONSTRUCTION OF CHC Khour"
District Jammu**

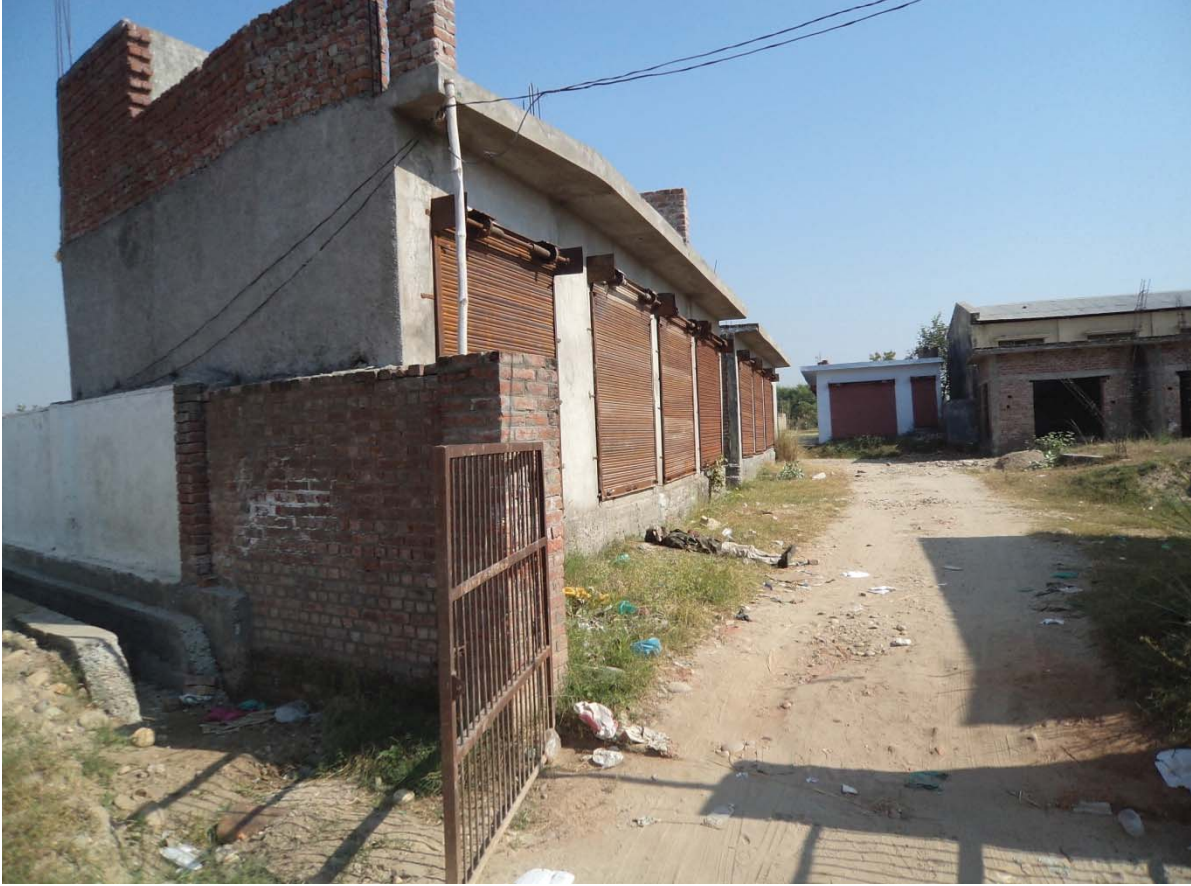
Shops constructed along the approach road to the hospital

(c) **Approach path with sharp bends:** On the front side of the hospital a number of new structures, which would be used as shops, have been constructed by the people who have donated the land for the hospital. The proprietary construction is haphazard's and has resulted in sharp bends/ curves on the single lane approach path connecting the hospital to the nearest blacktopped road leading towards Khour town. **The people who have donated land for the hospital seem to have exploited the commercial aspect besides performing a social/ human act.** It would be difficult at this juncture to ask the locals to dismantle the shops coming in the alignment of the approach path. However, the executing agency in consultation with H&ME Department may consider constructing an alternative approach path behind the shops from the left side corner of the hospital boundary towards the nearest black-topped road. The engineers of R&B seemed willing to construct such alternative approach path. The H&ME Department as well as R&B Department needs to examine the matter.

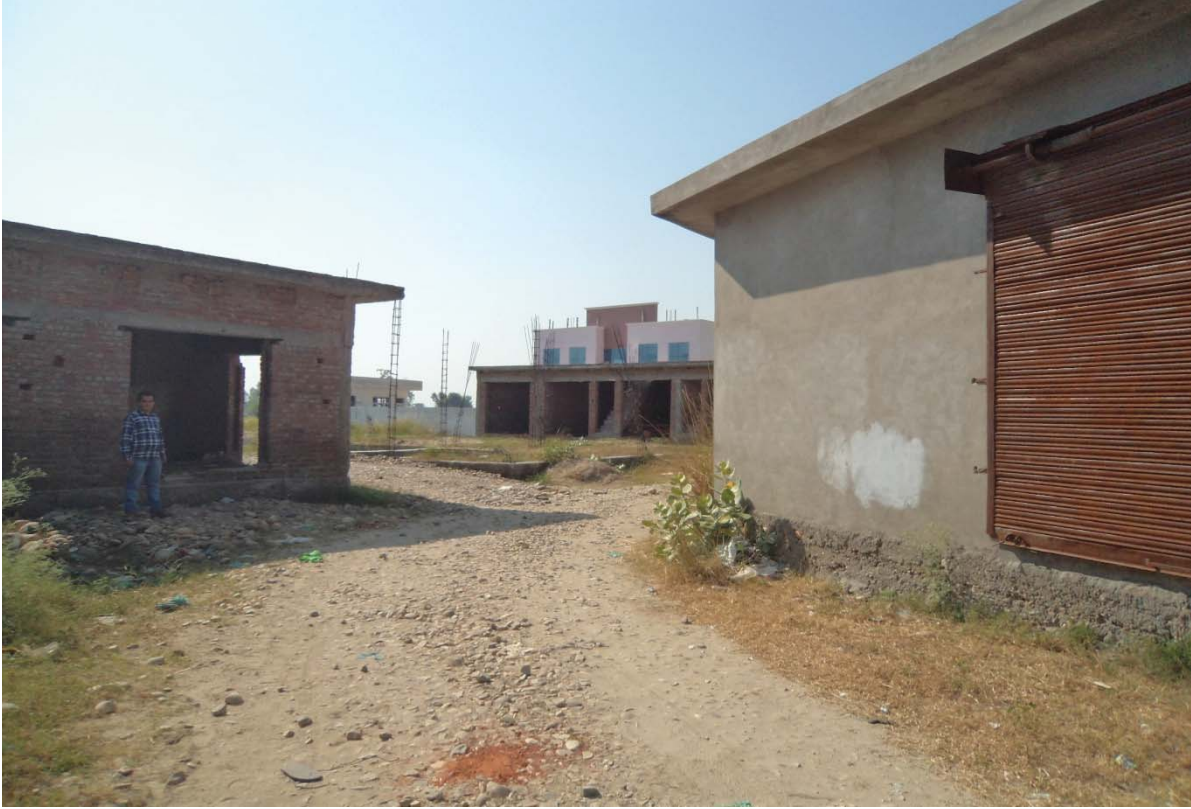
Approach path to the hospital from the nearest black topped road leading to Khour town has been developed for a length of about 200 meters but the road is yet to be black topped. **The approach path is single lane and has a couple of steep bends near the hospital gate due to haphazard's construction of shops by the locals along this path.**

Sharp bend on the approach road

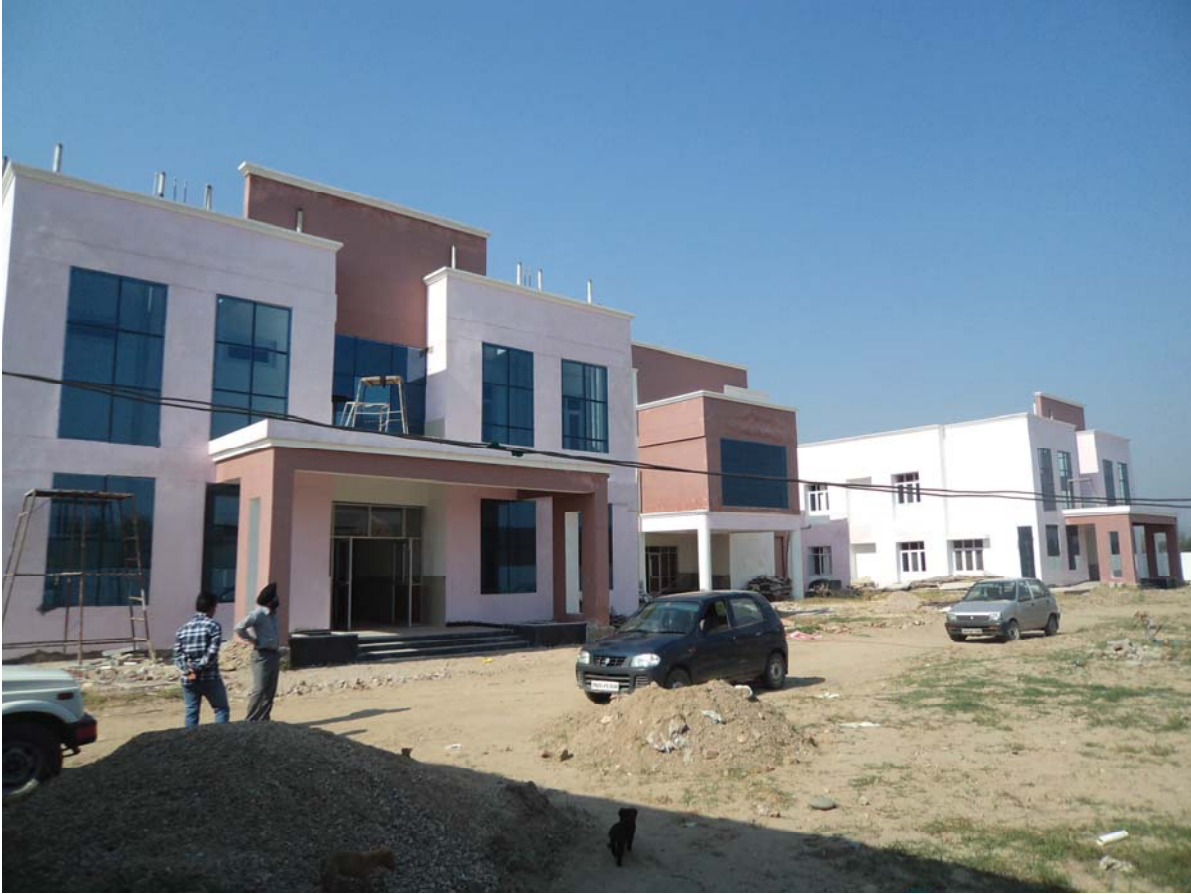
Front view of the hospital building

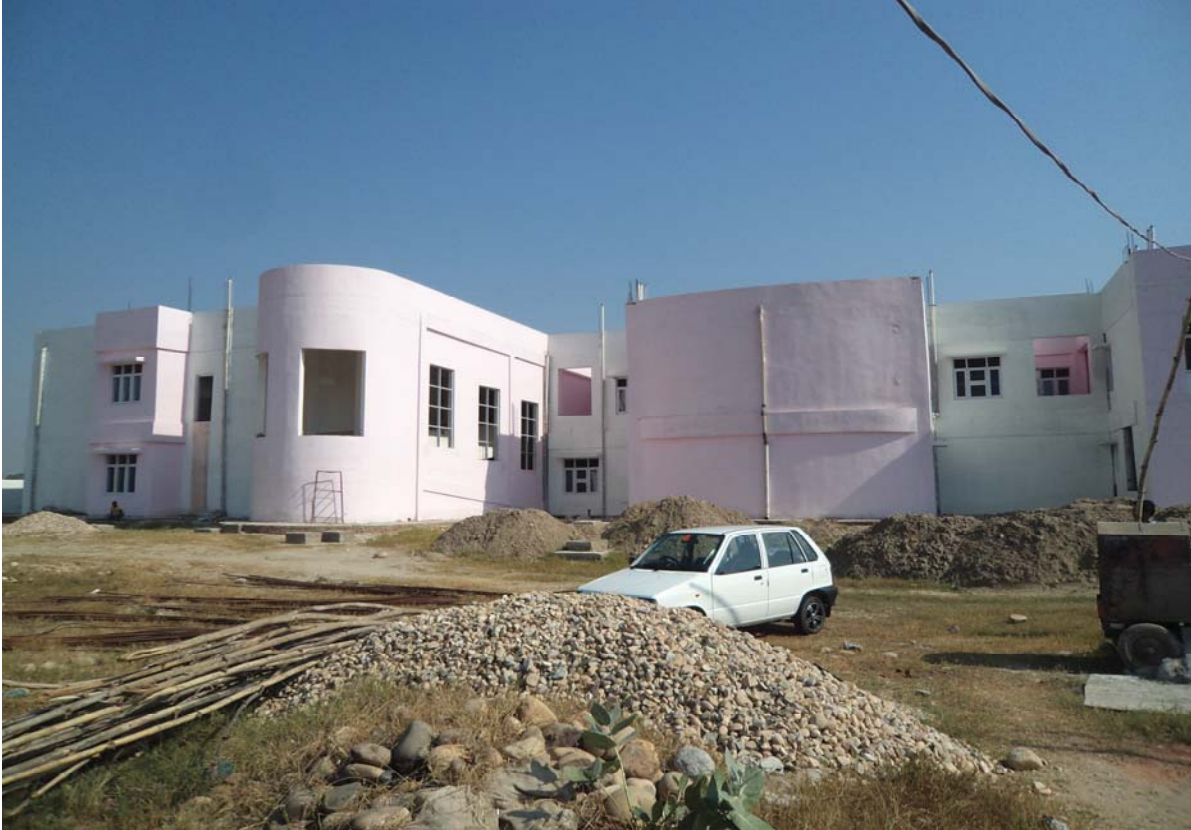
Rear view of the hospital building

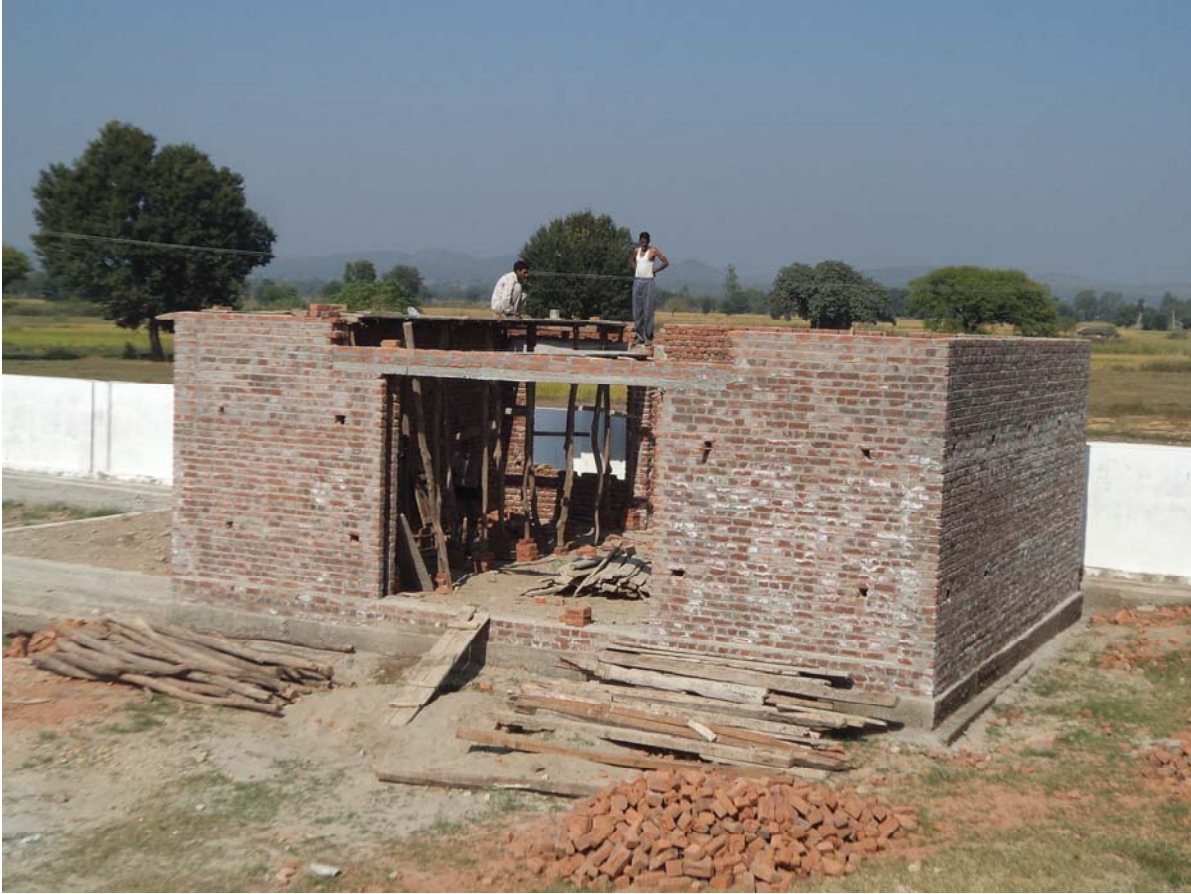
Electricity control room

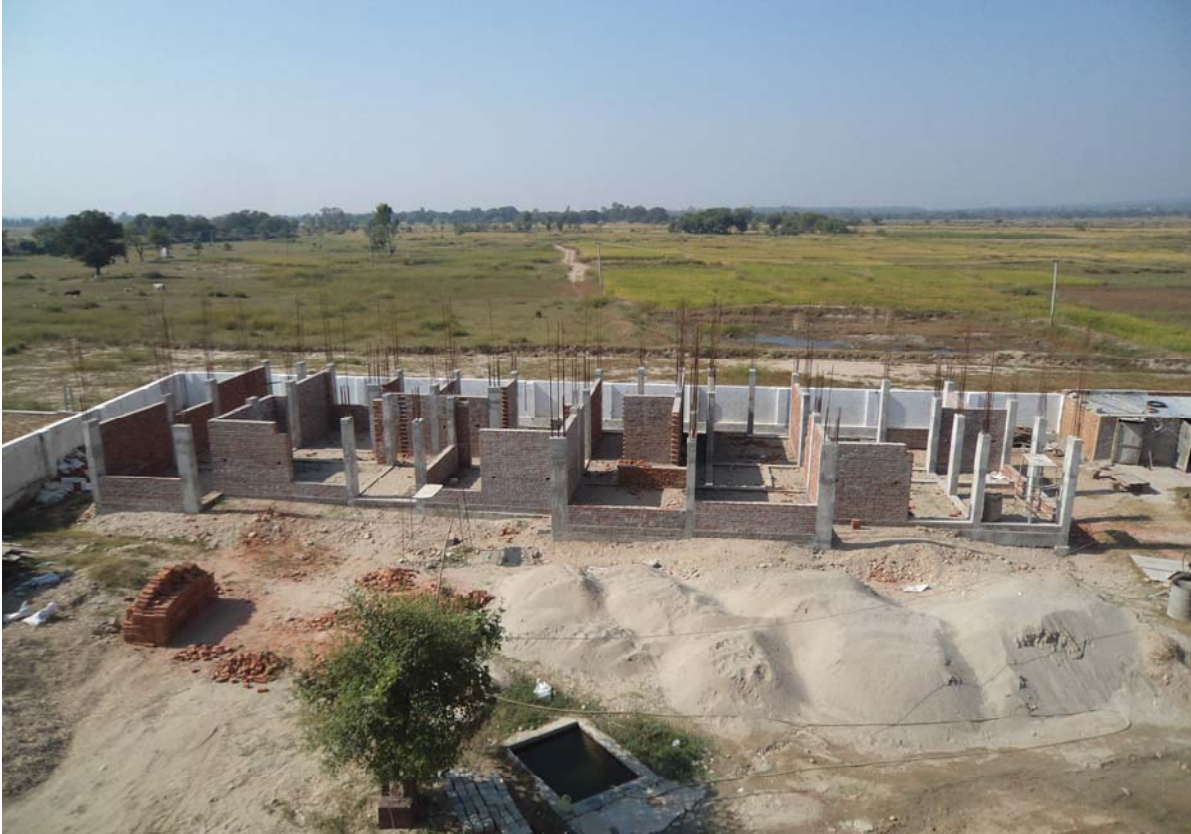
Construction work of ground floor of staff quarters at the rear side of the hospital complex is in progress. However, **the space available is inadequate for constructing 9 quarters for BMO/ MO (G+2) and 12 quarters for paramedical staff (G+2).** Another room is also being constructed behind the hospital for using it as an electricity control room. At the rear side of the hospital 3 pits have been dug to construct septic tanks, soakage pit, water reservoir etc. Here again the space seems inadequate.

Construction work of staff quarters in progress

(d) **Inadequate land:** Along the rear boundary wall of the complex, construction work of staff quarters is in progress. The land available at the rear is inadequate for construction of 21 staff quarters as envisaged in the revised DPR. Moreover, three huge pits have been dug behind the hospital for construction of septic tanks, water storage, solid waste disposal etc. However, the space seems inadequate. The H&ME Department as well as R&B Department will have to look into this matter as well.
