GOVERNMENT OF JAMMU & KASHMIR
Chief Minister's Monitoring Cell

Physical verification report of the project namely
"Construction of Govt Degree College, Bijbehara,
District Anantnag"

PHYSICAL VERIFICATION REPORT

| Name of the Project: | Construction of Govt. Degree College Bijbehara, District Anantnag |

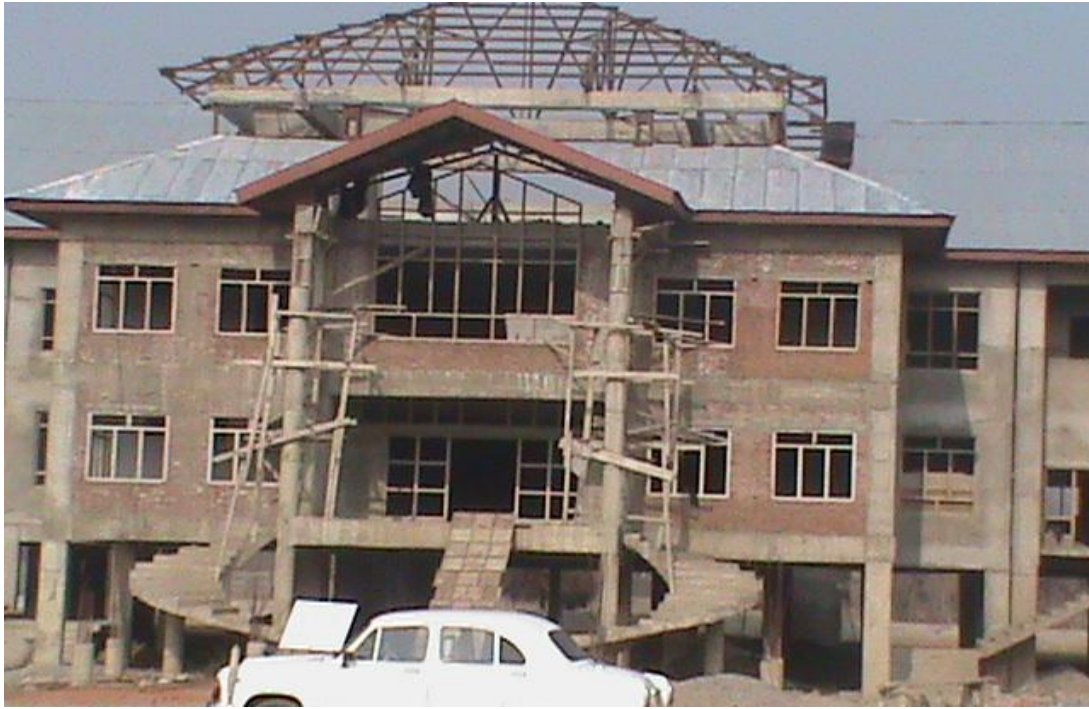
The super structure has been completed with the left and right wings of the building roofed. The roof work for middle portion are in progress.

Middle portion of the college building

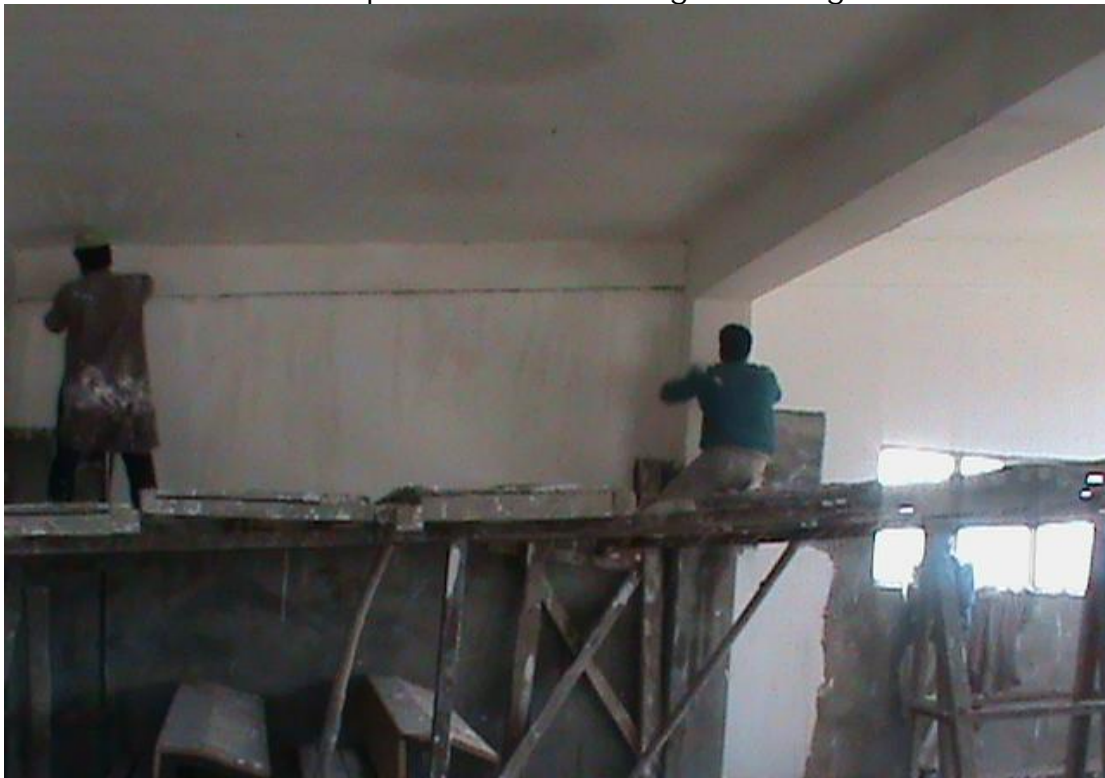
The finishing work by way of POP in the rooms/halls and laying of tiles in the toilet is under way. Deodar wood has been used for window and door frames in the entire building. The work of fixing window shutters of Kail wood was found in progress during the field visit.

POP work in the rooms/halls

The executing agency should take up the work in double shifts so as to ensure that the project is completed before March, 2012 and made functional from the next academic session. The agency should maintain proper and regular supervision as it has been doing, particularly at a time when the finishing works are under progress.

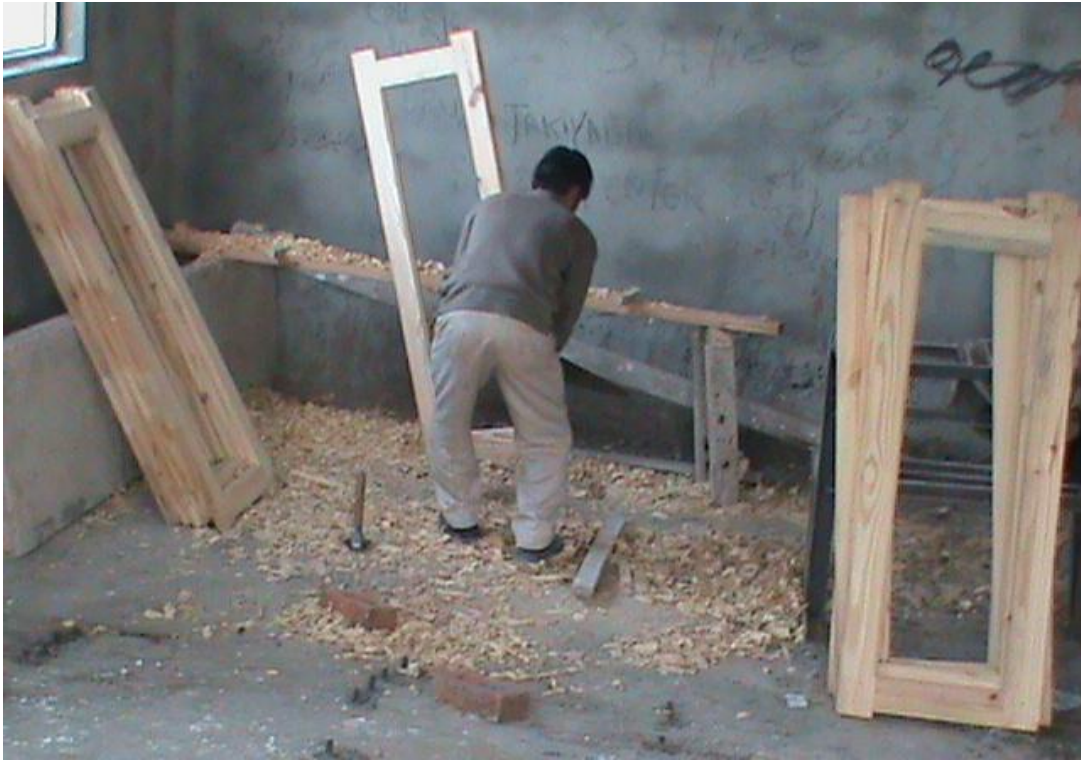
Fitting and fixing of window shutters in progress

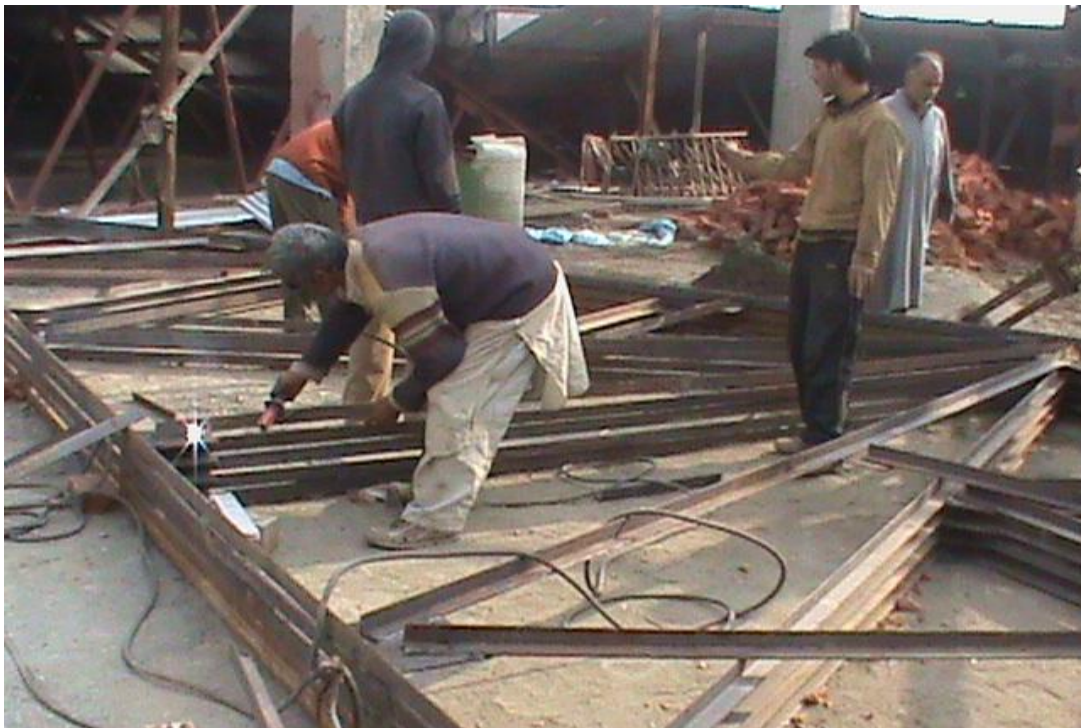
The building has been roofed with CGI sheeting of 0.63 mm (24 gauge) over steel truss except the middle portion for which the work was under progress. The CGI sheet roofing as well as steel (structural steel and tar steel) has been procured from SAIL with OPC 43 grade JK Cement is being used in the construction.

Work of installation of steel truss on top of Middle portion underway

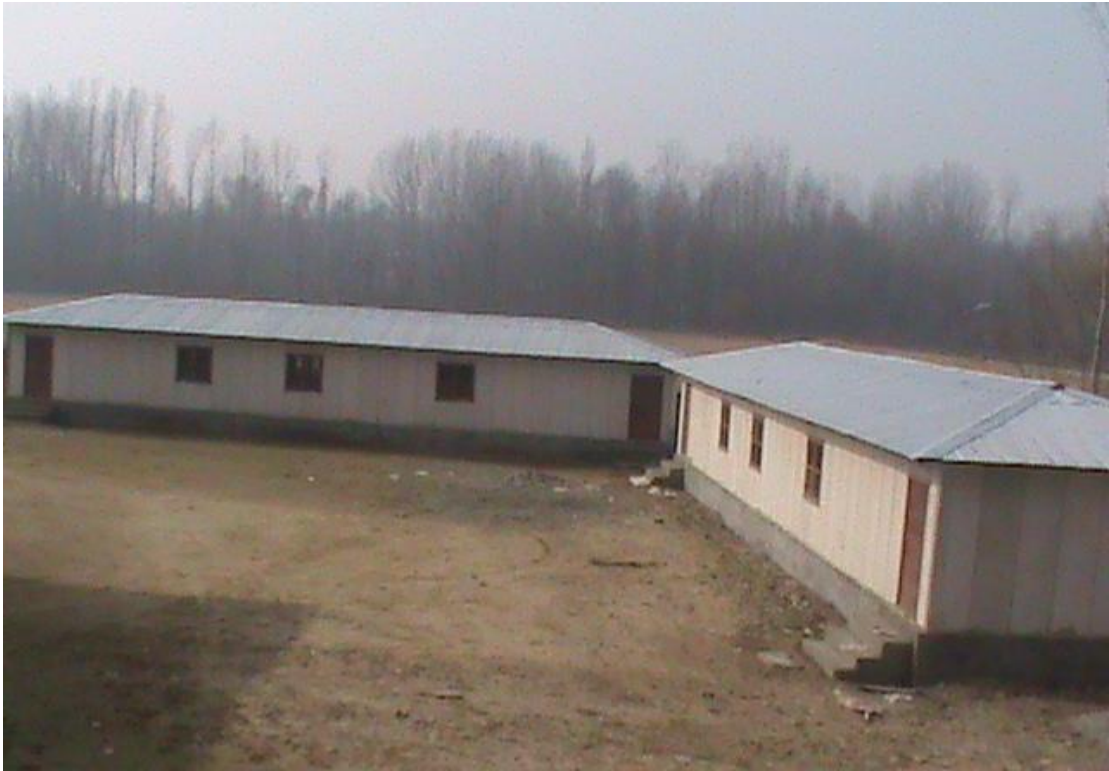
Three prefab huts have also been erected within the premises just in contiguity to the college building, which shall be used as additional accommodation for the college.

Prefab huts constructed within the college premises

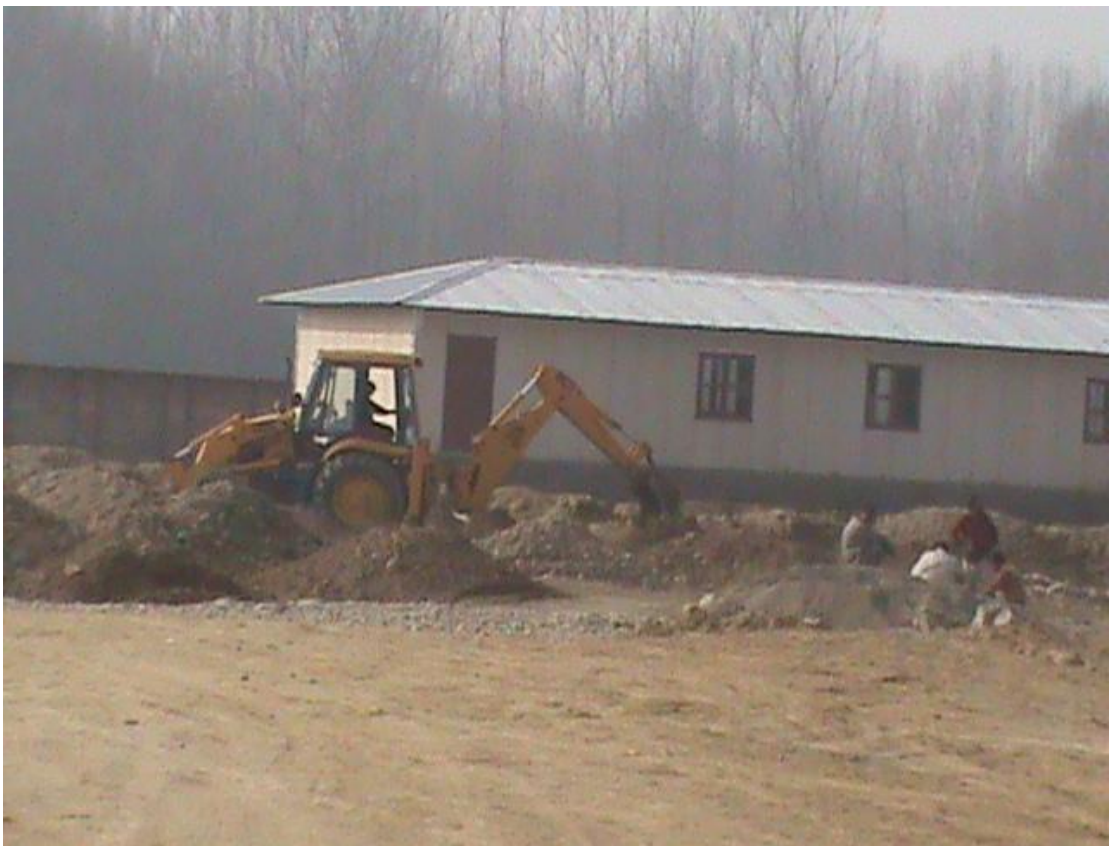
Being a low level area and to prevent the floods in the area, the whole chunk of 61 kanals of land (except portion occupied by building) is being developed by way of earth filling with an average height of 5-6 ft. With the earth filling around the whole premises, it is hoped that this will help to a greater extent in combating the floods, as the increase in earth level will definitely help in absorption of the more rain water. About 45 kanals have been developed and the work on account of remaining portion of land for its development is also under progress.

Land development work in progress

It should also be ensured by the executing agency that the work of the land development by way of earth filling for leftover portion is completed very quickly so that it becomes stable by the snow and rains during winter.

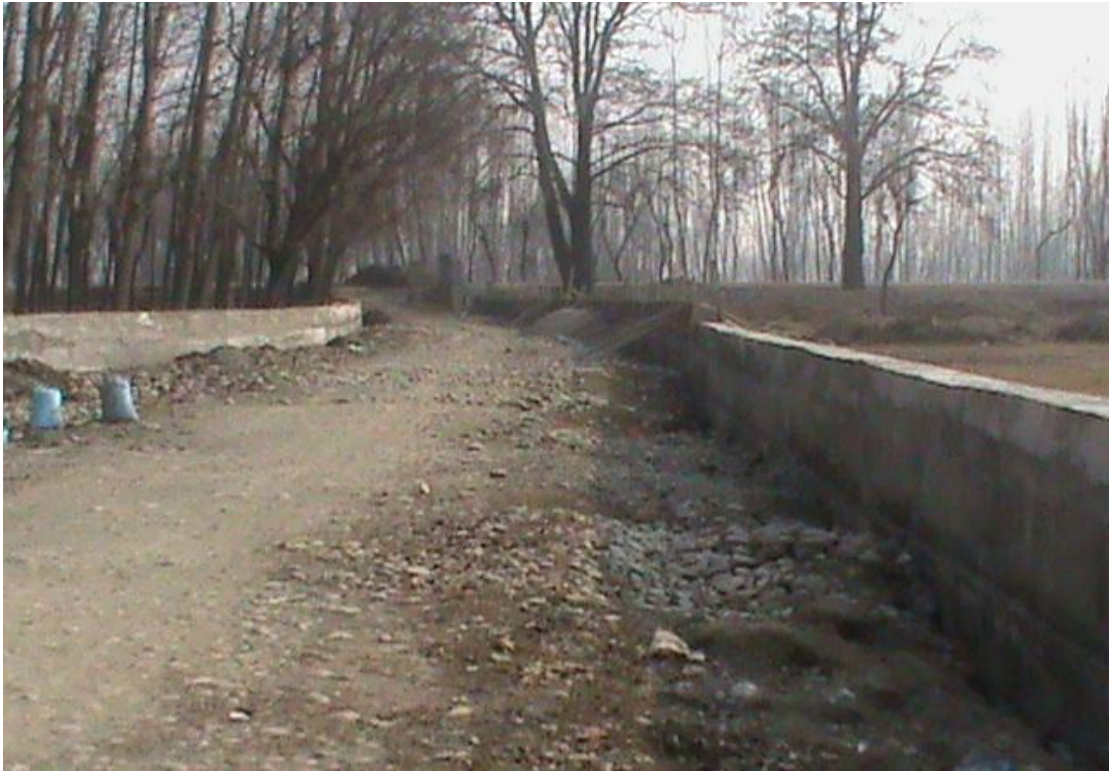
The approach road has been developed for a length of 0.3 Km from main road for transportation of building material to the site of construction.

The approach road near the entrance of the main gate is of the width of 36ft width against which the width of 20 ft can be used for parking of the vehicles outside the main entrance gate. The work on the further development of the approach road for bringing its level as per the gradient of the main road is under progress. The cement concrete blocks on either side of road for the purpose have been laid to ensure functioning of college during floods.

Approach road to College

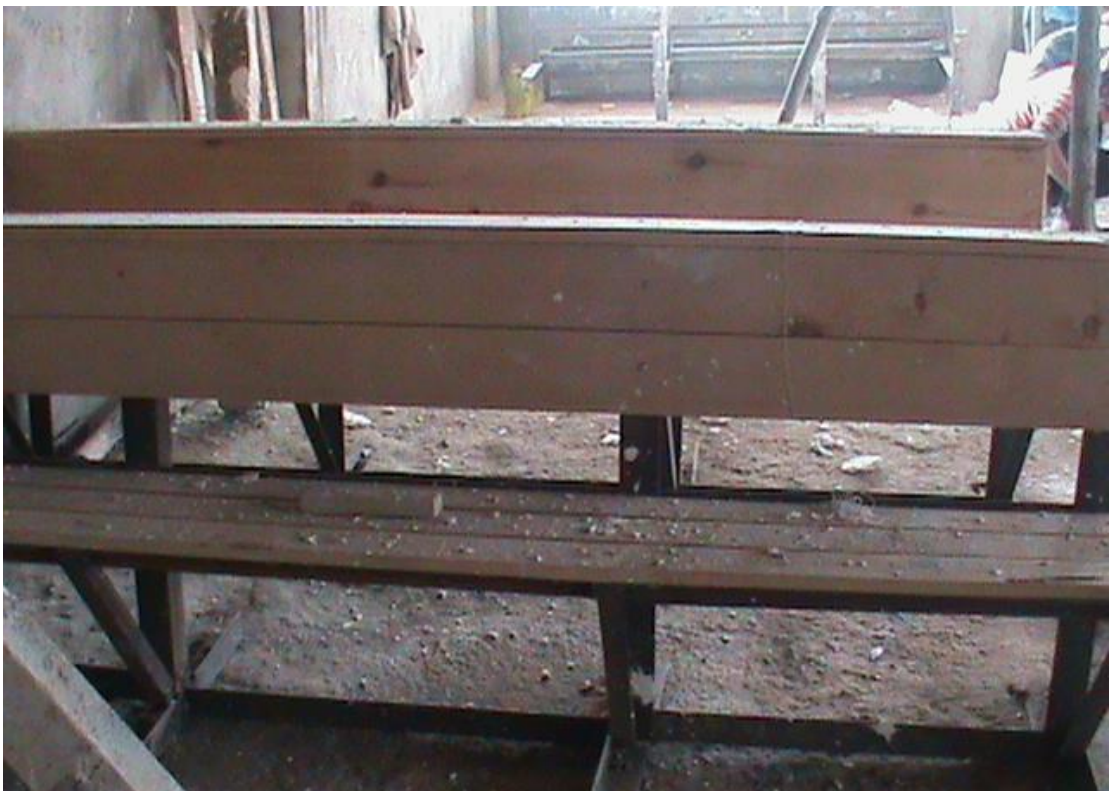
Benches installed in one of the lecture hall
