GOVERNMENT OF JAMMU & KASHMIR  
Chief Minister's Monitoring Cell

Physical verification report of the project namely  
"Construction of Grand Mosque (Khankah) at  
Charar-e-Sharief

PHYSICAL VERIFICATION REPORT

Name of the Project:	Construction of grand mosque (Khankah) at Charar-e-Sharief.
Source of Funding	State Plan
Executing Agency	JKPCC Ltd
Year of start of Work	July, 2002
Original target date of completion of the project:	July, 2005 (3 years from the date of start of work)
Revised target date of completion:	July, 2011

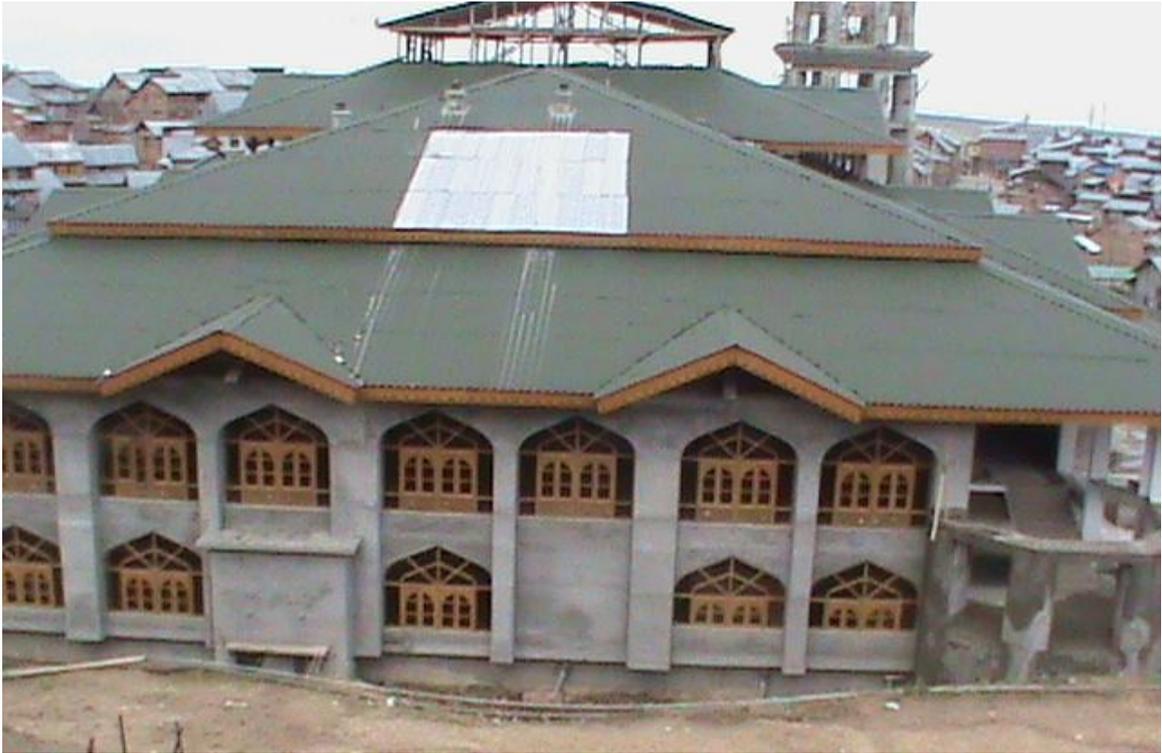
Left side view of the Khankah

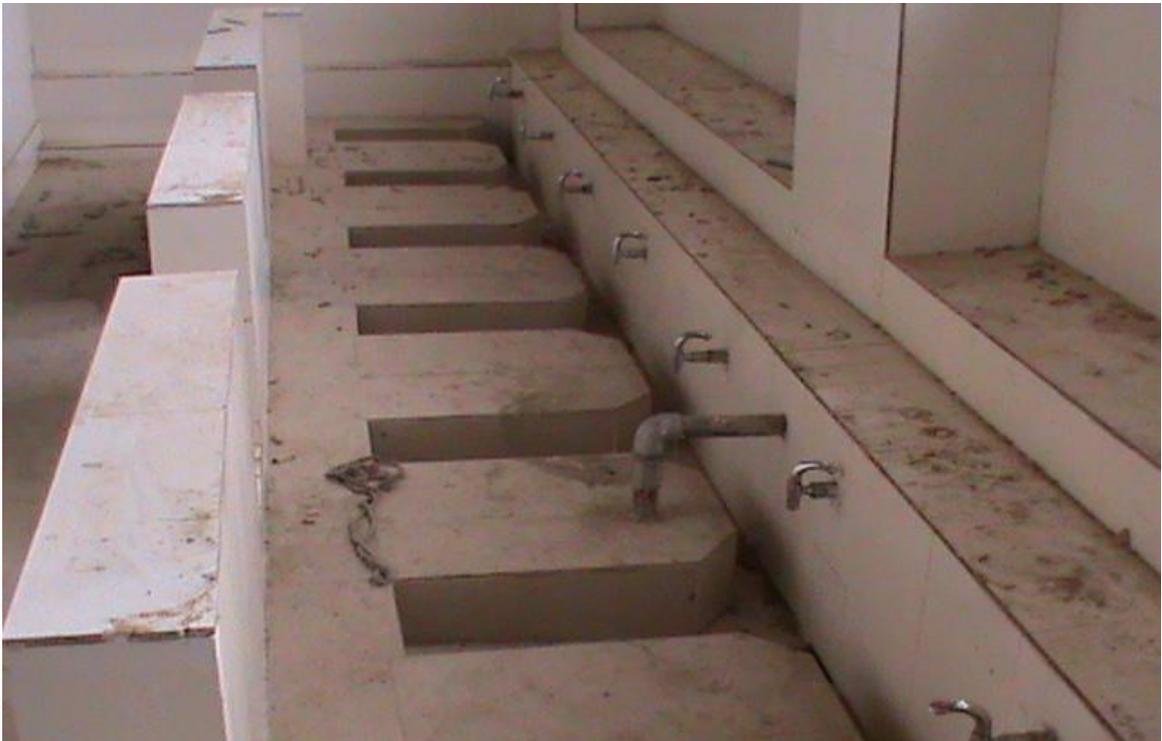
The scheme is not administratively approved as yet. The revised cost offer for an amount of Rs. 26.07 crore prepared by the JKPCC Ltd has been sent to the concerned quarters for necessary action. The overall quality of the works executed was found satisfactory. However, the workmanship quality in laying and fixing of the tiles in ablution points in the various areas was found lacking. The taps provided in these ablution points are absolutely local made which need to be replaced by standard quality taps.

Poor workmanship quality in laying and fixing of tiles in ablution points with providing of local made taps.

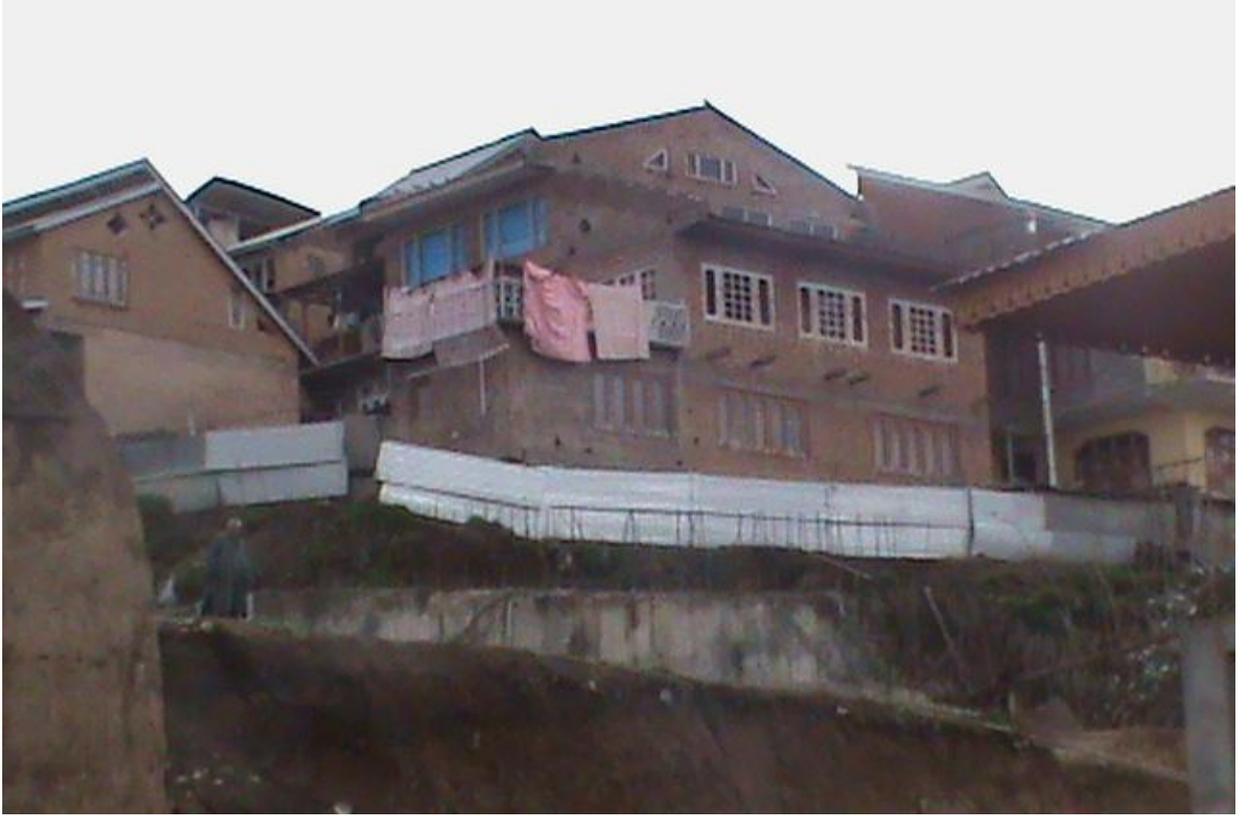
A huge retaining wall of about 300 Rft is also proposed to be constructed on the southern side of the mosque, which is presumed very essential after the terrace cutting for safeguarding the lives and property of the locals who are residing at the top of the vertical cliff created on account of construction of Hamam portion of the Khankah. The construction of the retaining wall forms part of the revised cost offer. However, the construction of the said retaining wall was taken up almost two years back but the work was suspended immediately after construction of only 40 Rft R/wall at higher contour due to some land dispute of the locals of the area with the Government. There are three persons who are claiming that their property which was gutted in the fire incident of 1995 has not been properly compensated. They have also approached the Hon'ble Court and obtained a status-quo order which has prevented the further execution of the said retaining wall. The Deputy Commissioner, Budgam had constituted a committee for settling such issues with the concerned persons on out of the court settlement basis. However, two of the three plaintiffs have entered into an agreement with the District Administration on out of court settlement basis. But the third plaintiff namely Shri Amir-ud-din Baba had not agreed to. He has reportedly obtained a decree passed by the Hon'ble Court in his favour for demarcation of 10 marlas of land at the top of the said cliff.

Sites where construction of retaining wall has been suspended

Once the cases are withdrawn by the two plaintiffs from the Court, the construction of the retaining wall needs to be resumed immediately as it becomes imperative for safeguarding the life and property of inhabitants residing at the top of vertical cliff which otherwise is apprehensive of suffering damage at any point of time which can be a cause of concern for the government. However, the portion of the retaining wall which has the claim of the third plaintiff can be taken up for construction after the final settlement of the case.

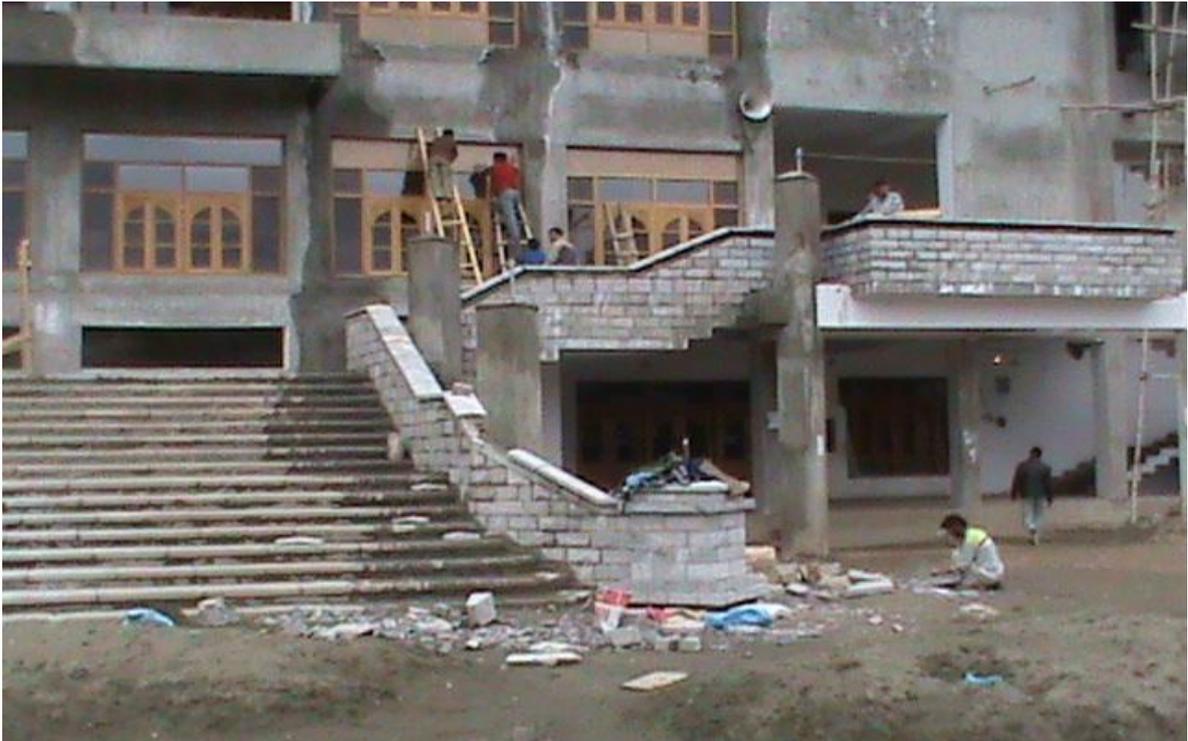
There is a main entrance stair of 24 feet width which directly takes to this floor. This stair is of RCC framed structure with Devri stone in flooring and parapets on its both sides, the work of which has been completed upto 95%. This floor has the following accommodation:-

Work in progress for construction of main entrance stair of the Mosque

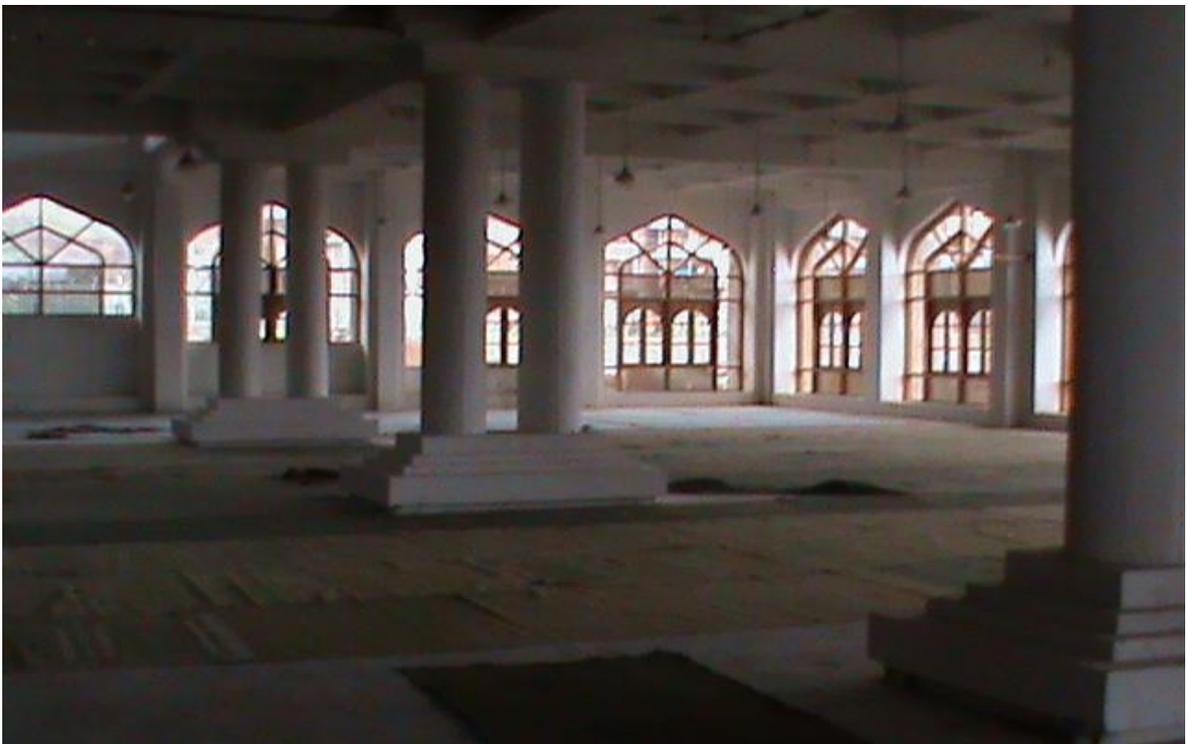
The Hamam portion has been completed and also stand tested. It can also be used as mosque during winters. Mehrab for main hall also completed. Construction of partition walls by way of brick masonry and joinery works in between the main mosque and hamam is in progress. Fixing of wire gauze window shutters and finishing works in walls and ceiling in the prayer hall, Hamam, foyer portion in the shape of Khatamband, gyp board and wooden ornamental cornice and paper mache works are yet to be executed.

Prayer Hall in the Ground Floor
