Chief Minister's Monitoring Cell

Physical verification report of the project namely  
"Upgradation of road from Puthkhah to Mongam"  
(PMGSY), Baramulla

### PHYSICAL VERIFICATION REPORT

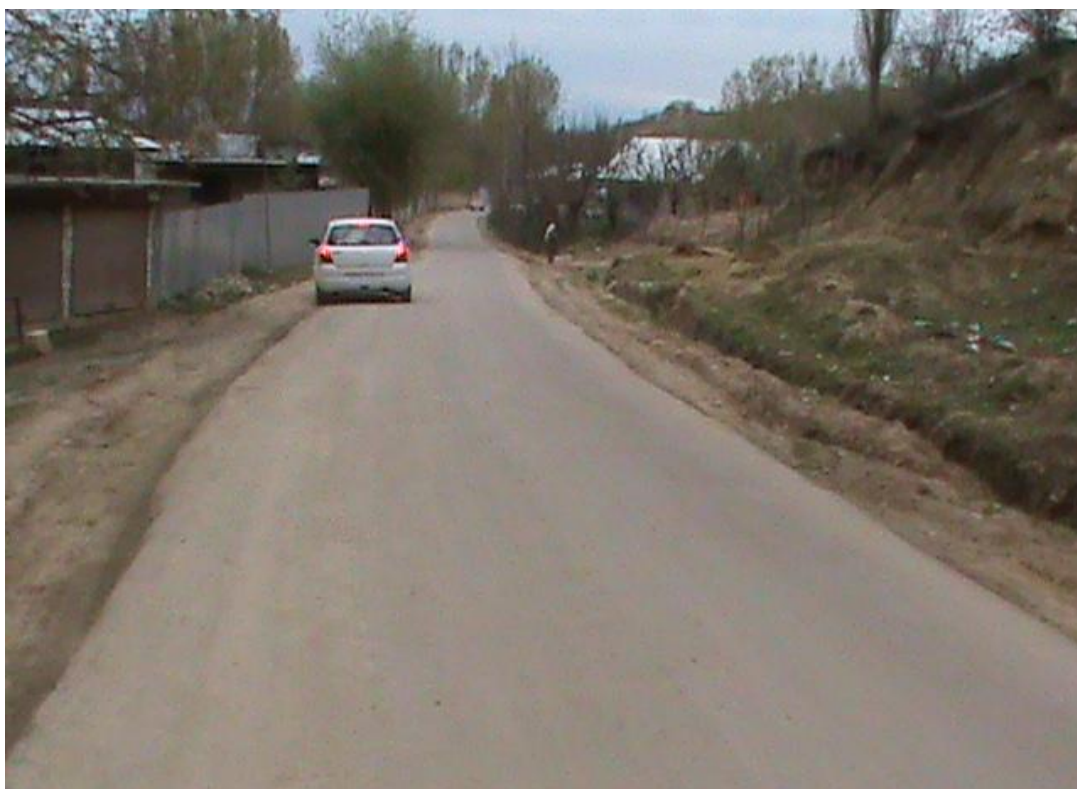
View of the blacktopped portion of Puthkhah – Mongam road, Baramulla

The completion of the scheme has already been delayed by one month. However the blacktopping of 2 Kms of road length has been done during the last summer. On the day of inspection the condition of the road was found good except at few spots where minor damages have caused to the road. The thickness of bitumen macadam and OGP was measured on spot and was found as per specification of the DPR. The width of the carriage of 12 feet as per DR norms was also found correct. One sqft of already laid macadam has been taken as a sample which shall be sent to Forensic lab for determination of quantity of tar and gradation of aggregates as per specification contained in the DPR.

Since it is mandatory on the part of the contractor as per the norms of PMGSY to maintain the road for a period of 5 years after its completion, so he needs to be asked for carrying out the repairs to the damaged spots of the already blacktopped portion of road immediately.

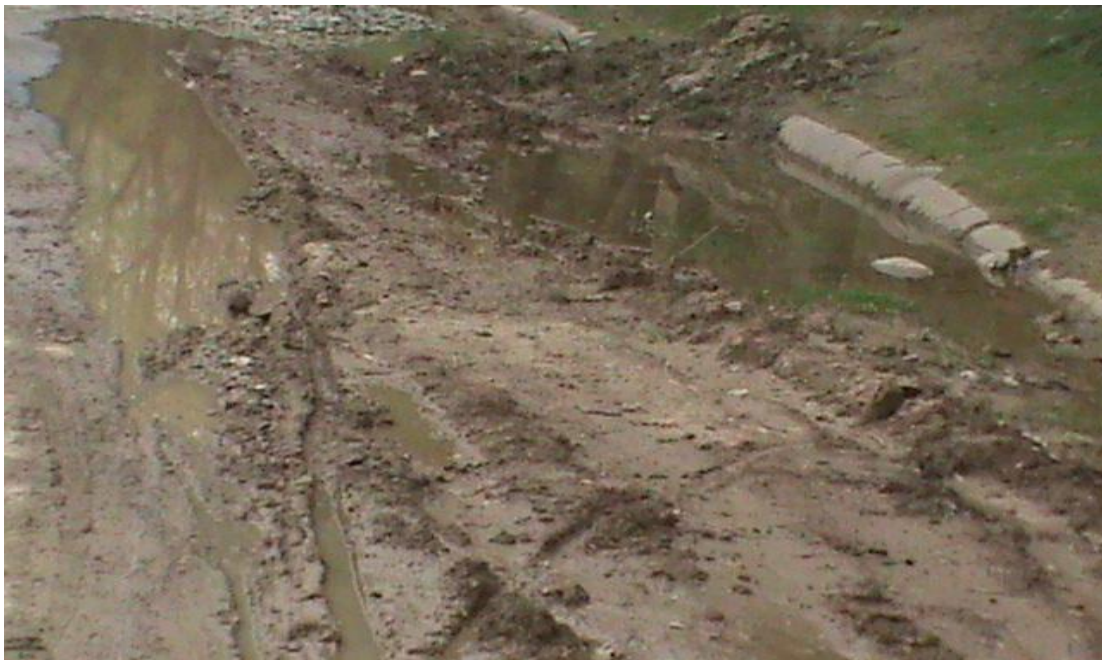
There is water supply pipe of 12"dia which runs parallel to the edge of the road for about 2500 Mts. This pipe was found leaking at many joints as a result of which the water gets accumulated on the road surface. There is every apprehension that the road surface may get damaged due to this water accumulation.

Water supply pipes leaking at the joints

PHE department may be asked to do the led jointing at the jointing points of the Water Supply pipe to avoid leakages which are very much apprehensive of causing damage to the road.

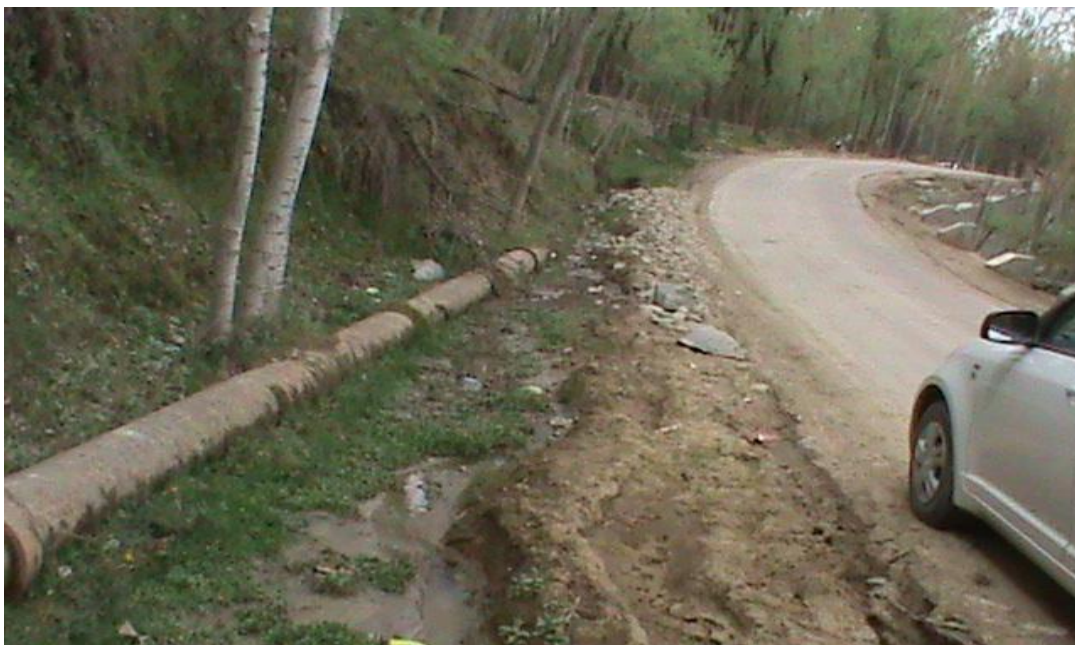
During inspection the opinion of the public was also sought. The public is demanding that the berms existing on either side of the road which are earthen ones should be made hard ones. These earthen berms besides being in a haphazard and messy manner have been posing lot of difficulties to the public as well as the transporters who have to move either to the left or right edge of the road for paving way to the other vehicles operating on this road in view of the limited carriage way of 12 feet. This situation has reportedly led to one or two accidents. This problem usually gets aggravated particularly during the rainy days.

View of the messy and jumbled earthen berms of the road

However, it was informed by the AEE, that the anticipated savings against the allotment of the work has been proposed for utilisation on conversion of earthen shoulders in to hard shoulders.

CE, PMGSY may consider the case for utilisation of the anticipated savings proposed by the PMGSY Division Baramulla for utilisation on conversion of the earthen berms into hard berms in the interest of the public of the area.

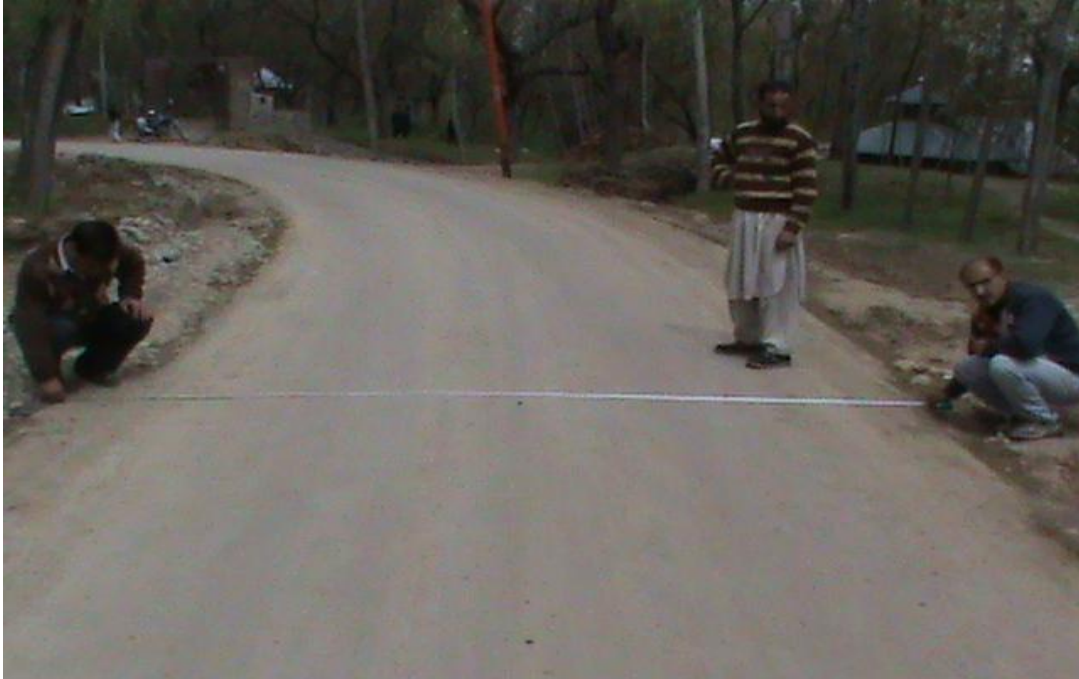
Measuring the width of the blacktopped road

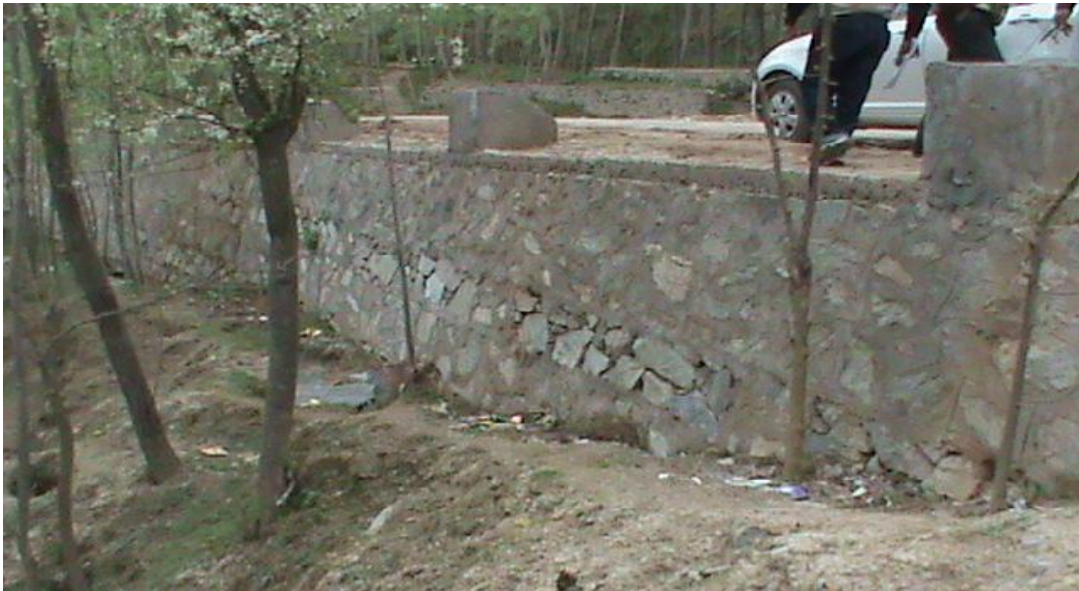
Retaining wall constructed near on Km 2<sup>nd</sup> of the road

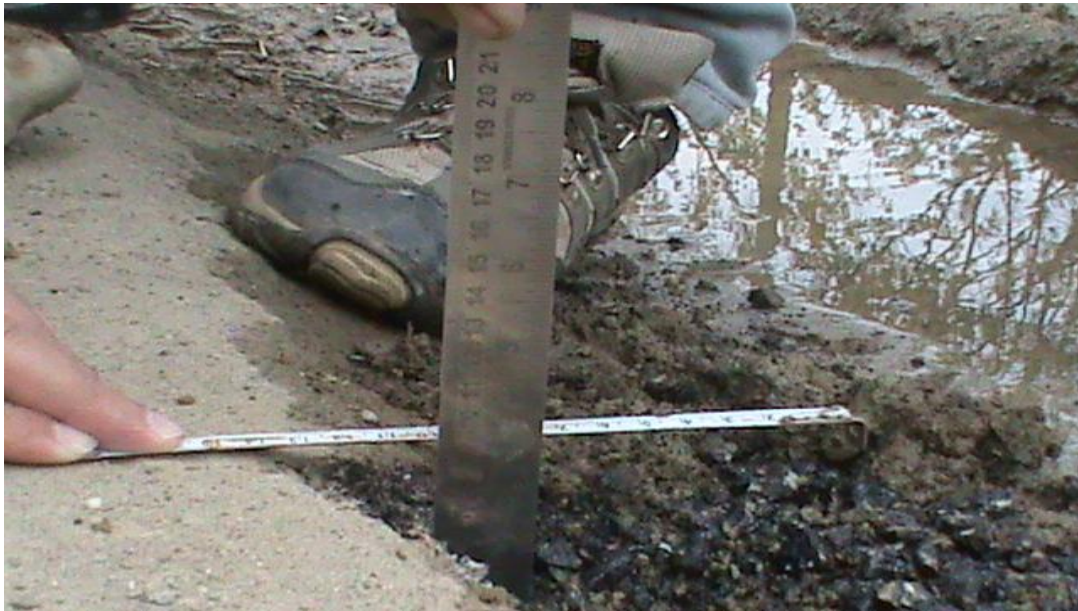
Checking thickness of the BM and OGP

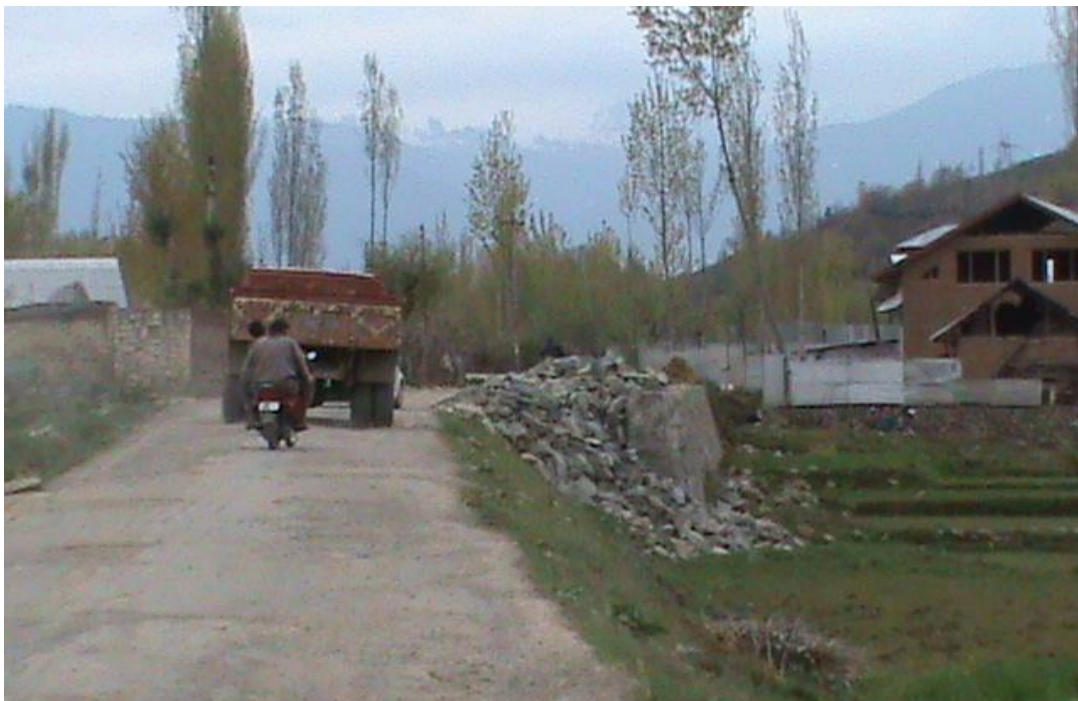
The executing agency is facing problem at Km 3<sup>rd</sup> for a stretch of 200 Mts where no basic work by way of GSB or WBM Grade II has been done. It was reportedly by AEE that one namely Shri Mohammad Sultan Rather has moved litigation in the court of law who is claiming that the road stretch exists on his proprietary land and has therefore, been demanding compensation for the same. The said person is obstructing the executing agency for taking up the work on this stretch of 200 Mts of road which includes also construction of Retaining Wall of 100 Rmts.

Spot at which the obstruction is caused in construction of Retaining wall and road

The CE, PMGSY is required to take all possible steps and make all possible efforts to get the court case settled as quickly as possible so that the work on the stretch of 200 mts of road length which is coming almost in the middle of the total road length of 5.7 Kms is also carried out including construction of retaining wall of 100 Mts. He may also impress upon the concerned Xen to ensure the completion of the blacktopping of the remaining portion of the road in the month of May, 2010 as the date of completion of the work has already expired besides dressing of the jumbled earthen berms for making them of even level.
